**Quail Crossing Townhomes 8708
1419 Red Mountain Drive
Longmont, CO 80504**

Level 1 Reserve Analysis

Report Period – 01/01/14 – 12/31/14

**Date of Property Observation - May 21, 2013
Project Manager - Matthew Woytek
Main Contact Person - Mrs. Francie Orvis, Community Manager**

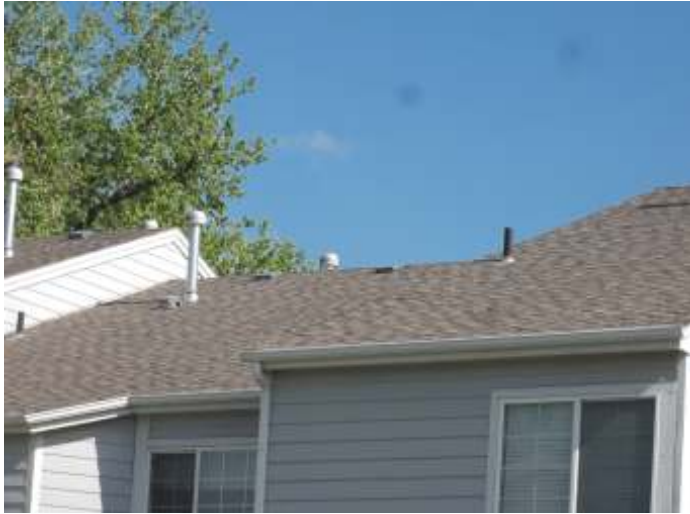
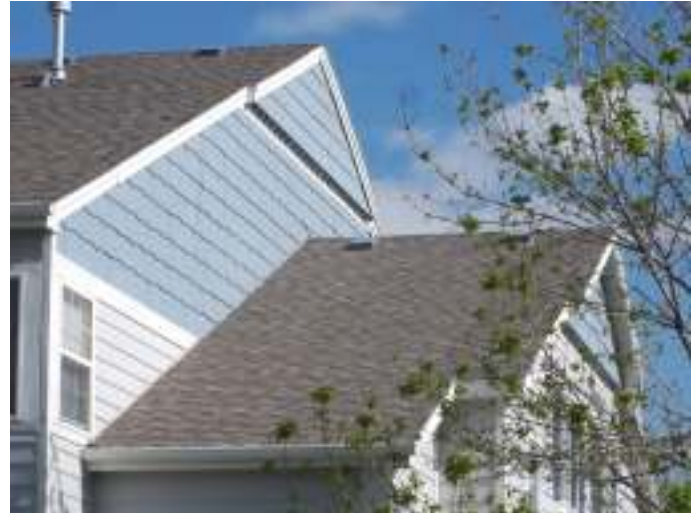
Comp #: 105 Comp Shingle Roof - Replace (1)

At time of observation it was reported that these roofs should have approximately 9 - 10 years of useful life left. These are "30 year" rated shingles, however, with the temperature fluctuations, small hail events and high winds in this climate, we recommend the association reserve to replace shingles every 20 - 25 years. We have split roof replacement into 3 phases to help ease budgeting concerns.

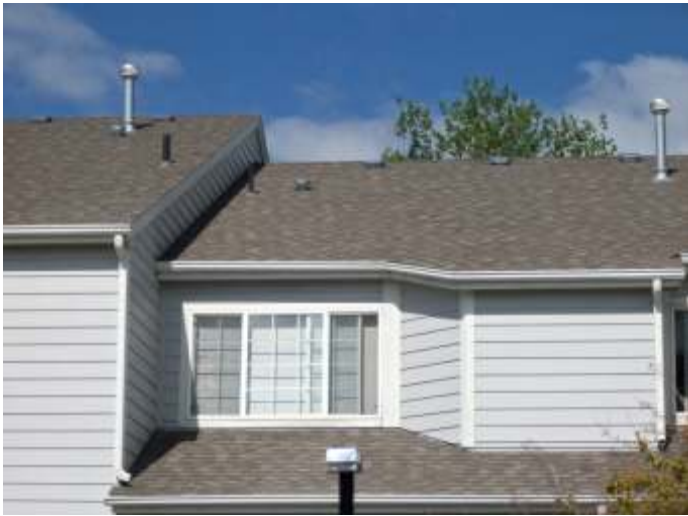
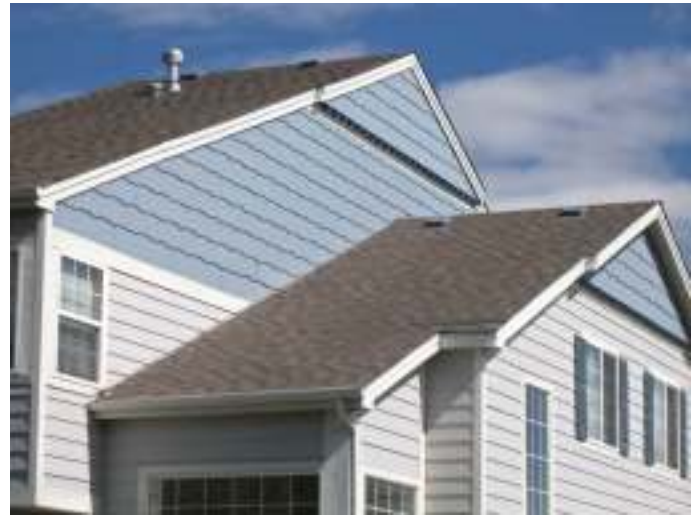
Comp #: 106 Comp Shingle Roof - Replace (2)

At time of observation it was reported that these roofs should have approximately 9 - 10 years of useful life left. These are "30 year" rated shingles, however, with the temperature fluctuations, small hail events and high winds in this climate, we recommend the association reserve to replace shingles every 20 - 25 years. We have split roof replacement into 3 phases to help ease budgeting concerns.

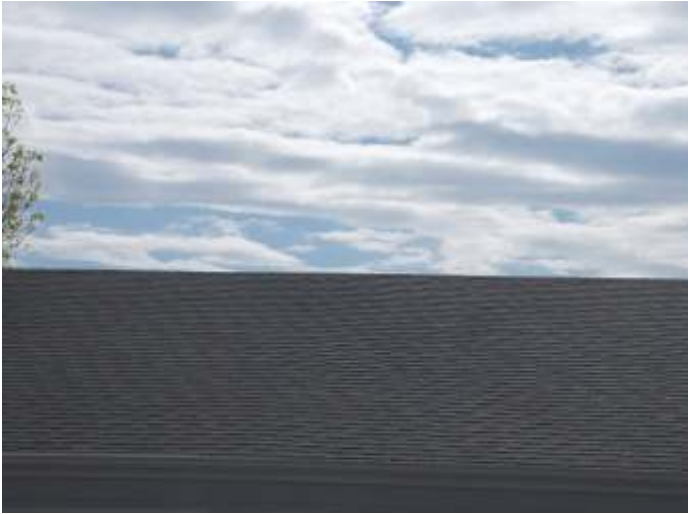
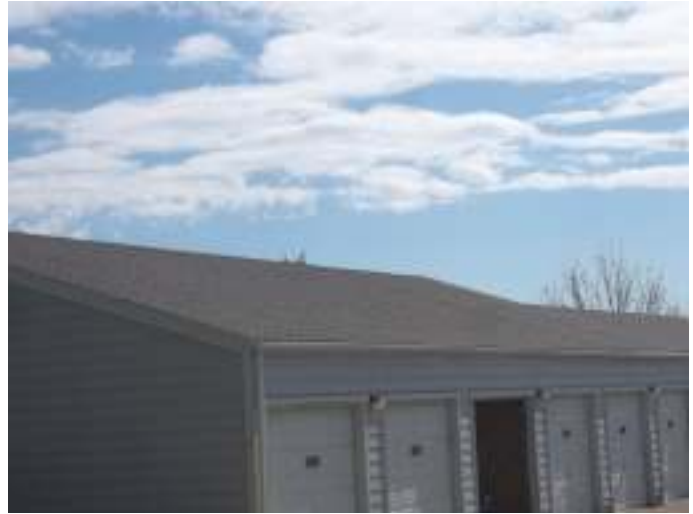
Comp #: 107 Comp Shingle Roof - Replace (Garages)

At time of observation it was reported that these roofs should have approximately 9 - 10 years of useful life left. These are "30 year" rated shingles, however, with the temperature fluctuations, small hail events and high winds in this climate, we recommend the association reserve to replace shingles every 20 - 25 years. We have split roof replacement into 3 phases to help ease budgeting concerns.

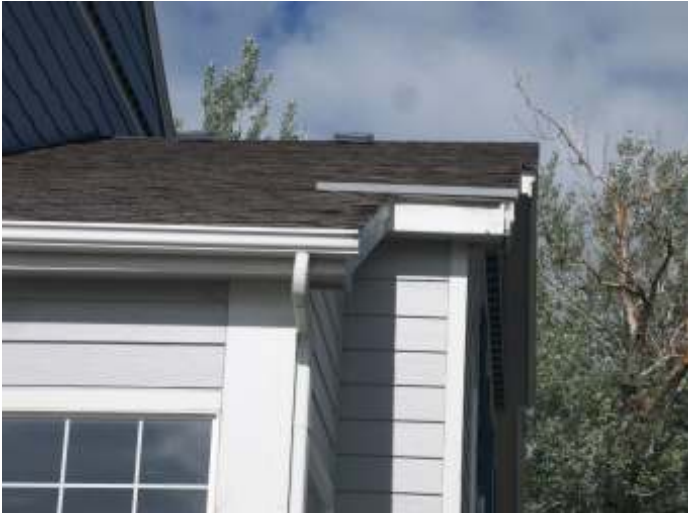
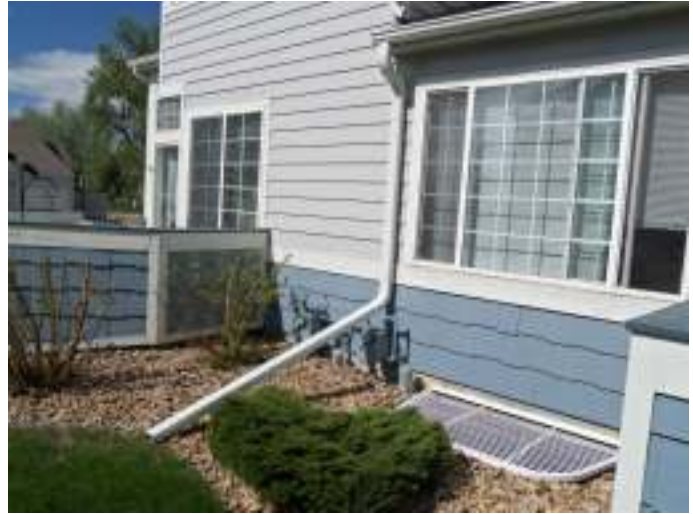
Comp #: 120 Gutters/Downspouts - Replace (1)

There were no unusual conditions with the installation of the lines or any evidence of damage. It is typical for debris, such as roof granules and dirt, to build up in the lines. When debris remains in the raingutters, it will stay wet after rains and snow melt which will cause premature deterioration of the materials. Therefore, we recommend cleaning out the lines at least once a year as a maintenance expense to ensure full life expectancy. It is typical to replace raingutters and downspouts at the same time as roof materials for best cost estimate.

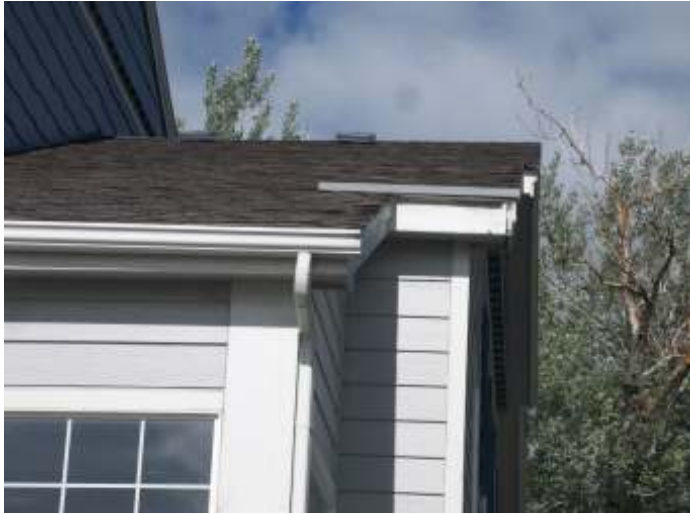
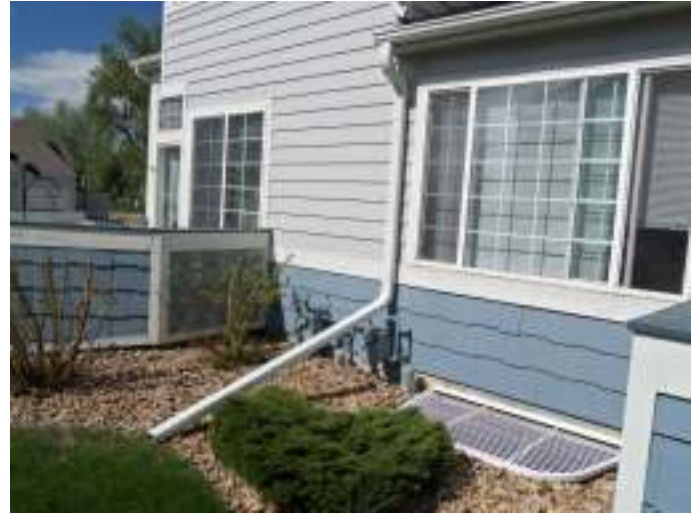
Comp #: 121 Gutters/Downspouts - Replace (2)

There were no unusual conditions with the installation of the lines or any evidence of damage. It is typical for debris, such as roof granules and dirt, to build up in the lines. When debris remains in the raingutters, it will stay wet after rains and snow melt which will cause premature deterioration of the materials. Therefore, we recommend cleaning out the lines at least once a year as a maintenance expense to ensure full life expectancy. It is typical to replace raingutters and downspouts at the same time as roof materials for best cost estimate.

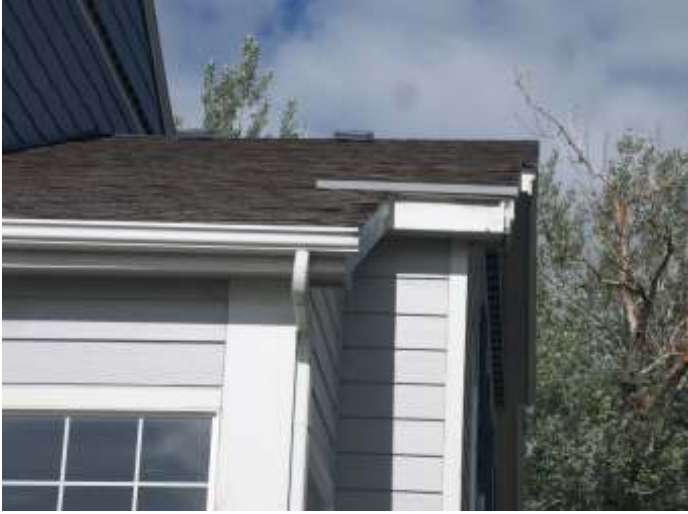
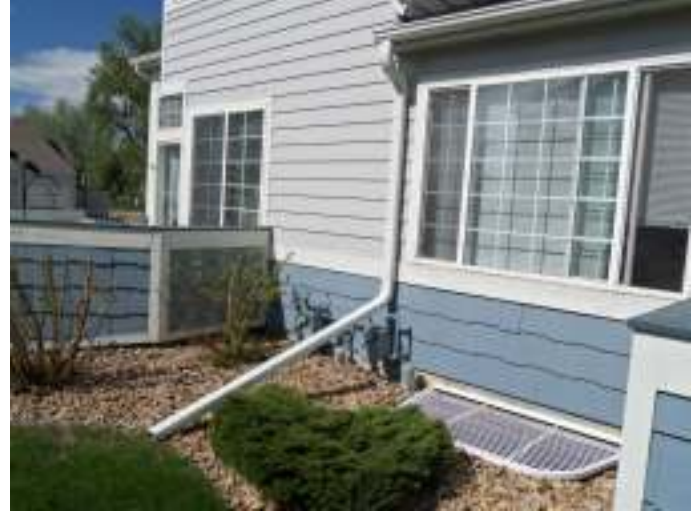
Comp #: 122 Gutters/Downspouts - Replace (Garages)

There were no unusual conditions with the installation of the lines or any evidence of damage. It is typical for debris, such as roof granules and dirt, to build up in the lines. When debris remains in the raingutters, it will stay wet after rains and snow melt which will cause premature deterioration of the materials. Therefore, we recommend cleaning out the lines at least once a year as a maintenance expense to ensure full life expectancy. It is typical to replace raingutters and downspouts at the same time as roof materials for best cost estimate.

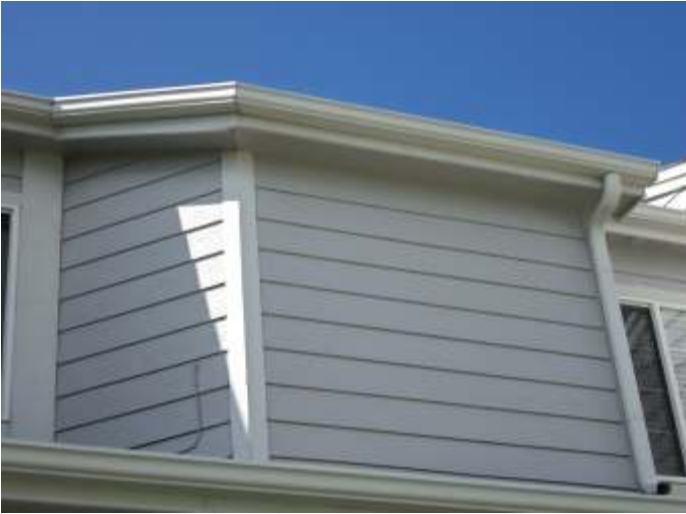
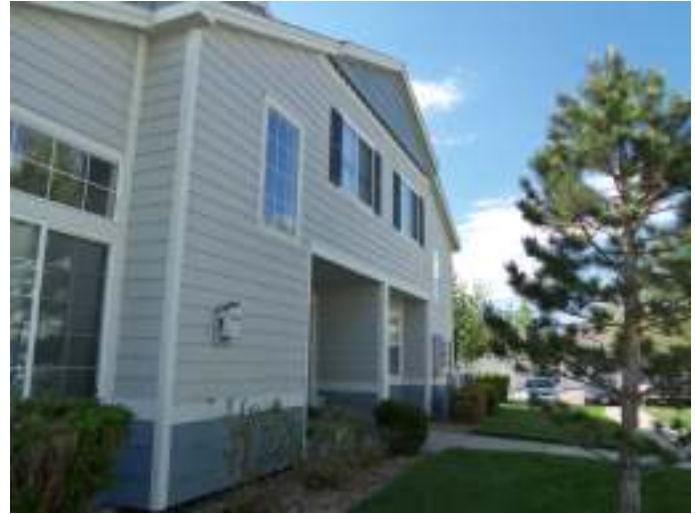
Comp #: 204 Building Ext Surfaces - Repaint (1)

At time of observation, majority of exterior surfaces appeared in fair to poor condition. Many areas of fading paint were apparent as well as some localized marking and missing paint. Although the worst areas are apparent in the darker blue color on the unit buildings, the entire surface should be planned for repainting every 5 years in order to ensure a proper appearance and to maximize the useful life of the siding. The association should also consider an operational line item to perform touch ups between repainting cycles to maintain the integrity of the painted surfaces.

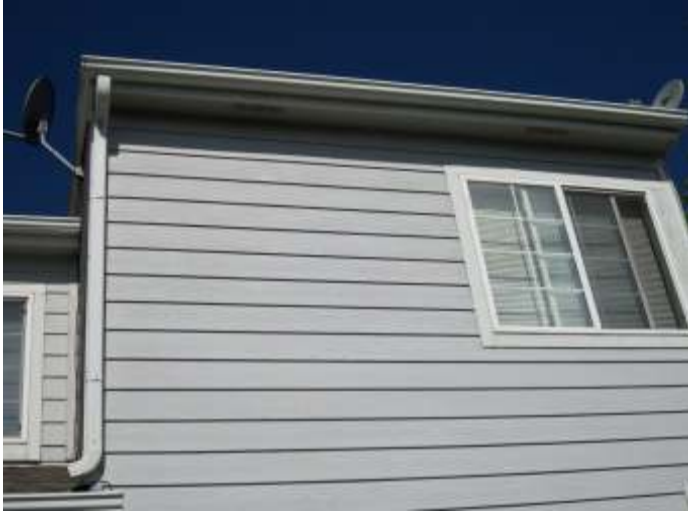
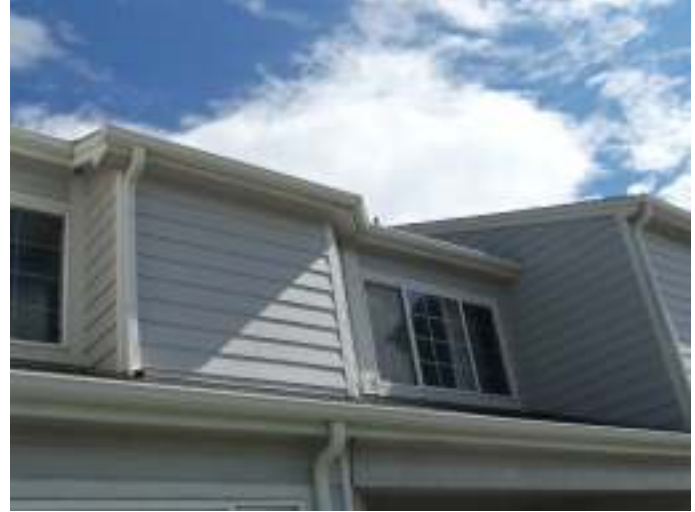
Comp #: 205 Building Ext Surfaces - Repaint (2)

At time of observation, majority of exterior surfaces appeared in fair to poor condition. Many areas of fading paint were apparent as well as some localized marking and missing paint. Although the worst areas are apparent in the darker blue color on the unit buildings, the entire surface should be planned for repainting every 5 years in order to ensure a proper appearance and to maximize the useful life of the siding. The association should also consider an operational line item to perform touch ups between repainting cycles to maintain the integrity of the painted surfaces.

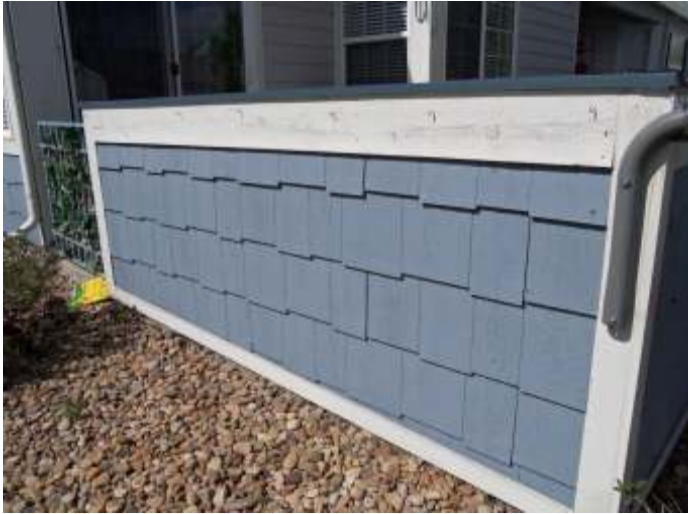
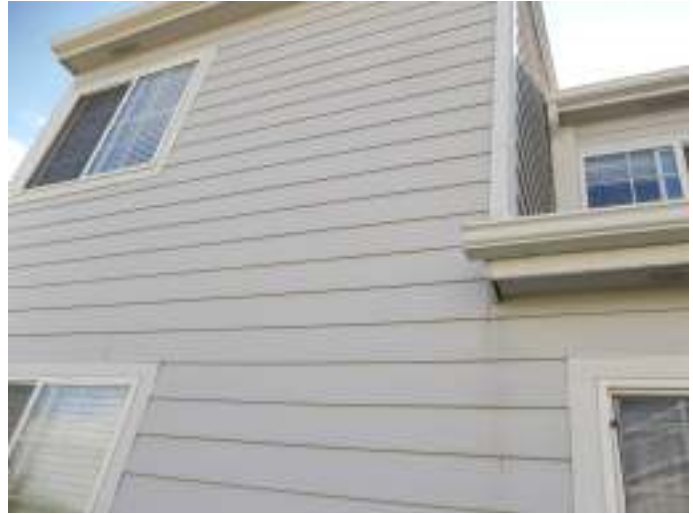
Comp #: 206 Building Ext Surfaces - Repaint (3)

At time of observation, majority of exterior surfaces appeared in fair to poor condition. Many areas of fading paint were apparent as well as some localized marking and missing paint. Although the worst areas are apparent in the darker blue color on the unit buildings, the entire surface should be planned for repainting every 5 years in order to ensure a proper appearance and to maximize the useful life of the siding. The association should also consider an operational line item to perform touch ups between repainting cycles to maintain the integrity of the painted surfaces.

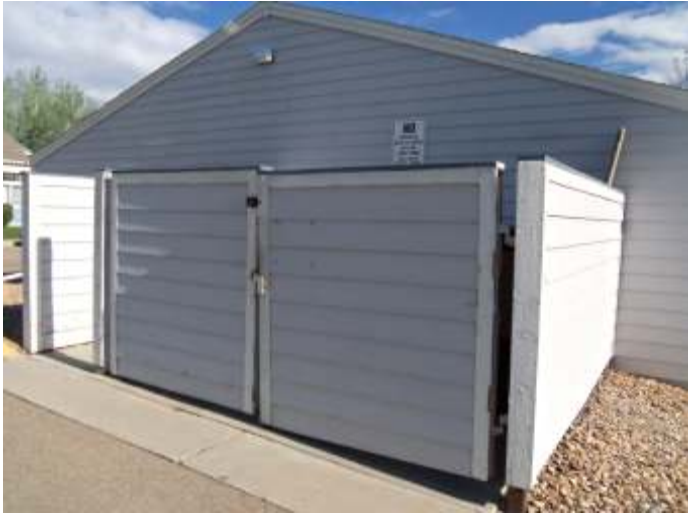
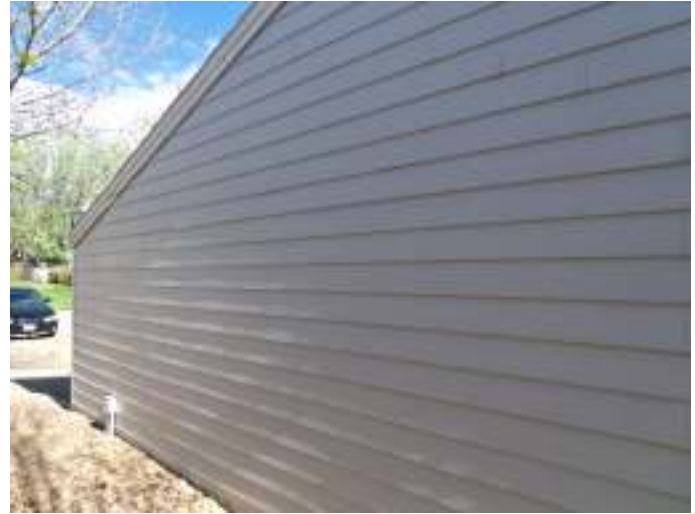
Comp #: 207 Building Ext Surfaces - Repaint (Garages/Refuse)

At time of observation, majority of exterior surfaces appeared in fair to poor condition. Many areas of fading paint were apparent as well as some localized marking and missing paint. Although the worst areas are apparent in the darker blue color on the unit buildings, the entire surface should be planned for repainting every 5 years in order to ensure a proper appearance and to maximize the useful life of the siding. The association should also consider an operational line item to perform touch ups between repainting cycles to maintain the integrity of the painted surfaces.

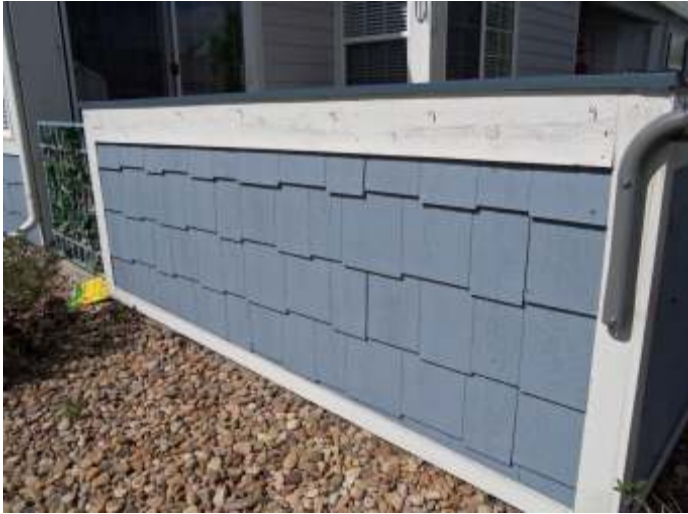
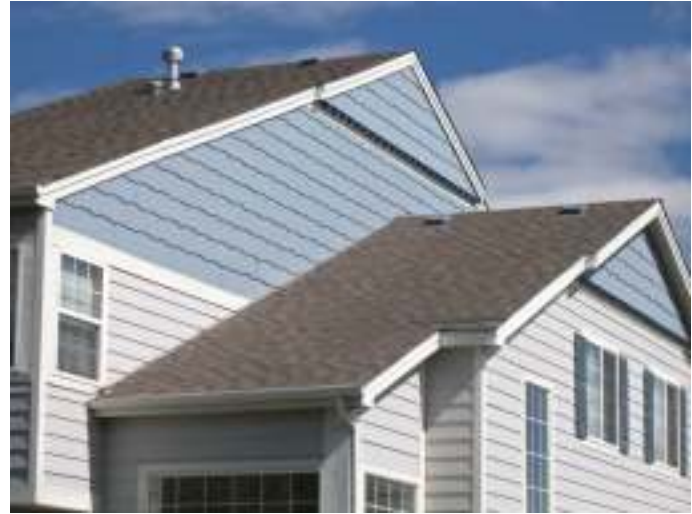
Comp #: 301 Hardboard Siding - Major Repairs (1)

The funding on this line item is for repairs to siding and trim that lies outside the scope of routine paint prep. We recommend reserving for this project to occur every paint cycle due to the appearance of the siding while on site, especially on patio walls. This allowance will likely help the association avoid completely replacing siding in the future. If deterioration rates change, we can adjust cost and/or frequency in future updates of this report.

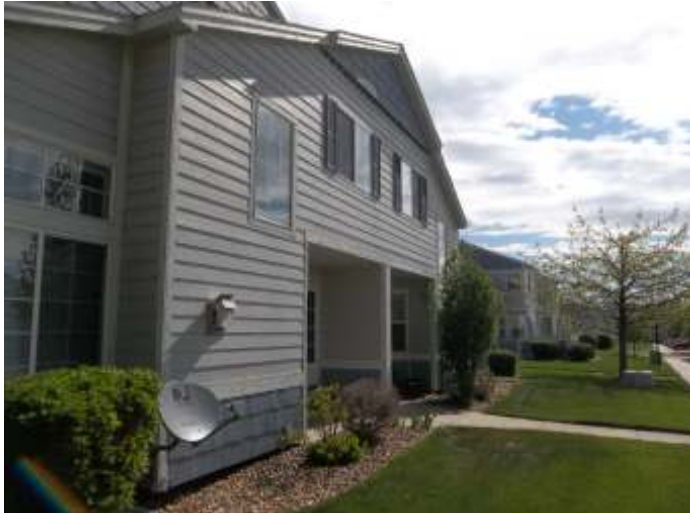
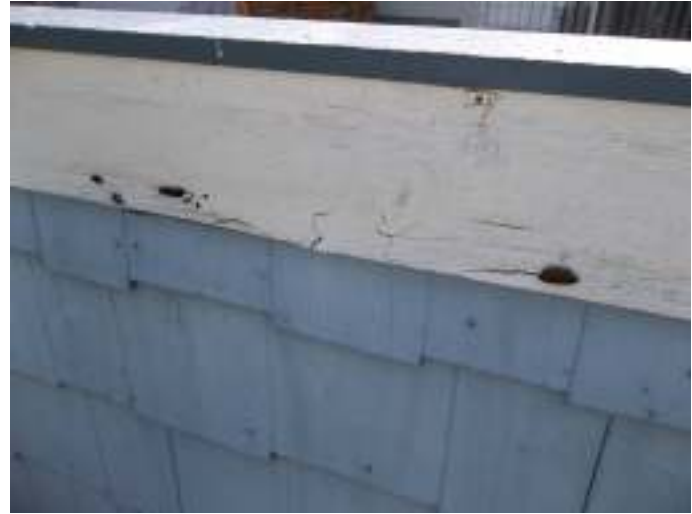
Comp #: 302 Hardboard Siding - Major Repairs (2)

The funding on this line item is for repairs to siding and trim that lies outside the scope of routine paint prep. We recommend reserving for this project to occur every paint cycle due to the appearance of the siding while on site, especially on patio walls. This allowance will likely allow the association from completely replacing siding in the future. If deterioration rates change, we can adjust cost and/or frequency in future updates of this report.

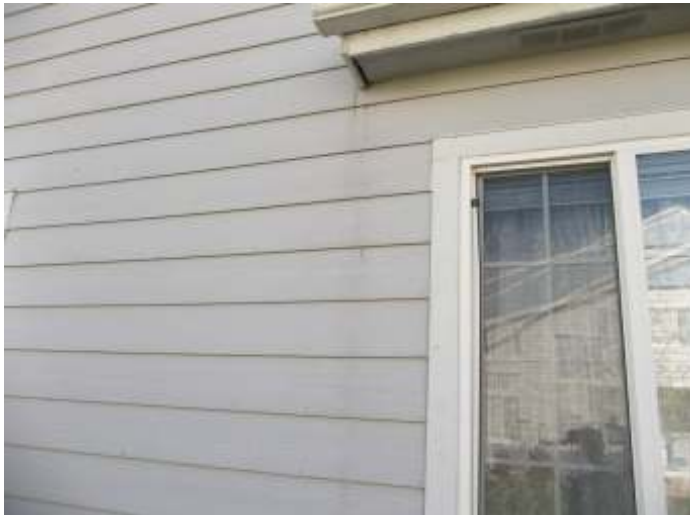
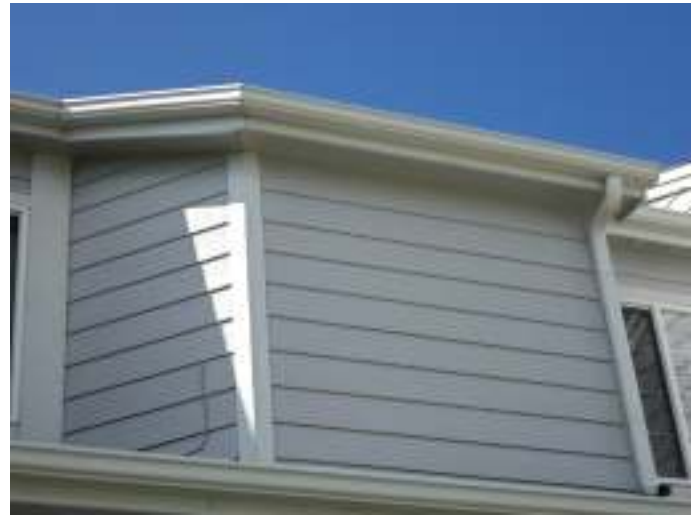
Comp #: 303 Hardboard Siding - Major Repairs (3)

The funding on this line item is for repairs to siding and trim that lies outside the scope of routine paint prep. We recommend reserving for this project to occur every paint cycle due to the appearance of the siding while on site, especially on patio walls. This allowance will likely allow the association from completely replacing siding in the future. If deterioration rates change, we can adjust cost and/or frequency in future updates of this report.

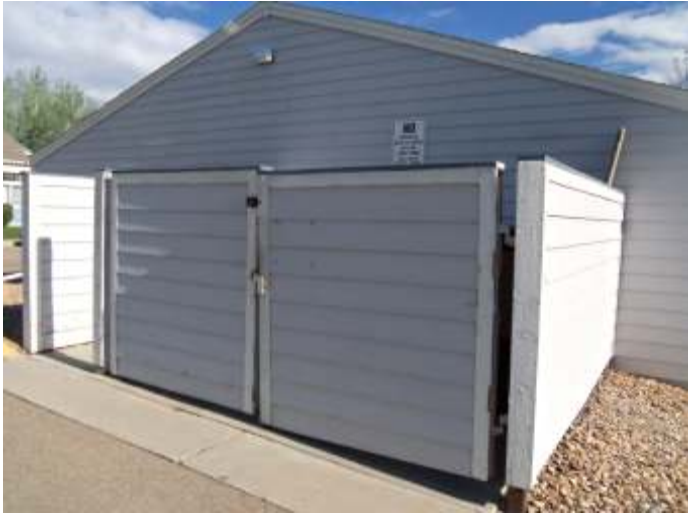
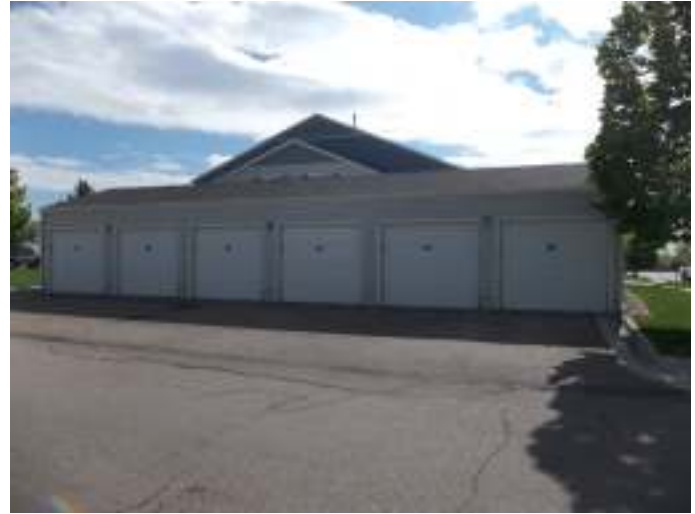
Comp #: 304 Hardboard Siding - Major Repairs (Garages/Refuse)

The funding on this line item is for repairs to siding and trim that lies outside the scope of routine paint prep. We recommend reserving for this project to occur every paint cycle due to the appearance of the siding while on site, especially on patio walls. This allowance will likely allow the association from completely replacing siding in the future. If deterioration rates change, we can adjust cost and/or frequency in future updates of this report.

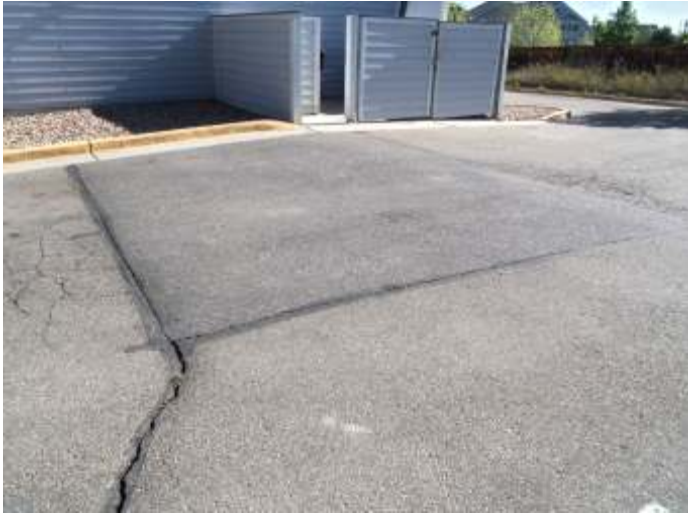
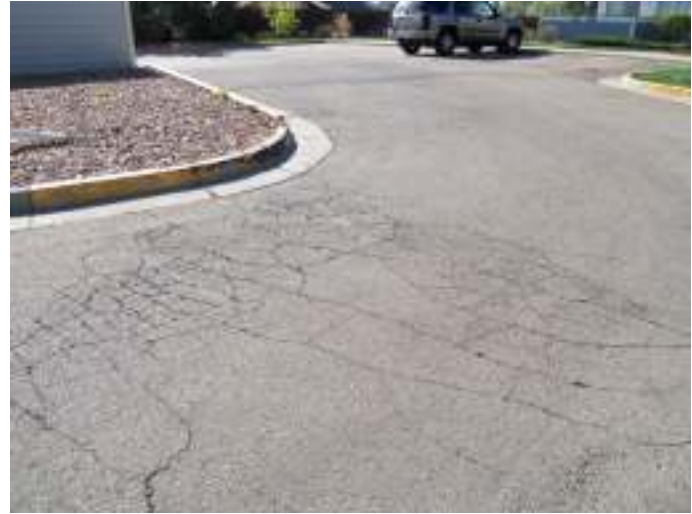
Comp #: 401 Asphalt - Overlay

Asphalt appeared in good to fair condition with extensive cracking noted at time of observation. In order to maximize the useful life of the asphalt, we recommend reserving to seal coat every 4 years (see component #402) as well as performing crack fill operations as an annual operating expense.

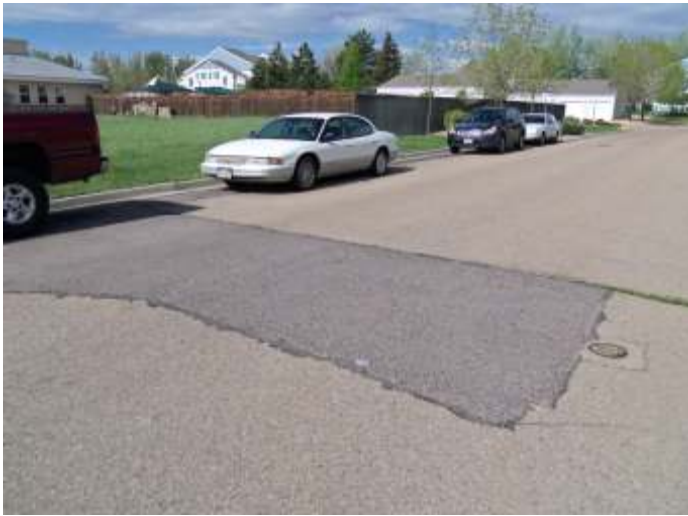
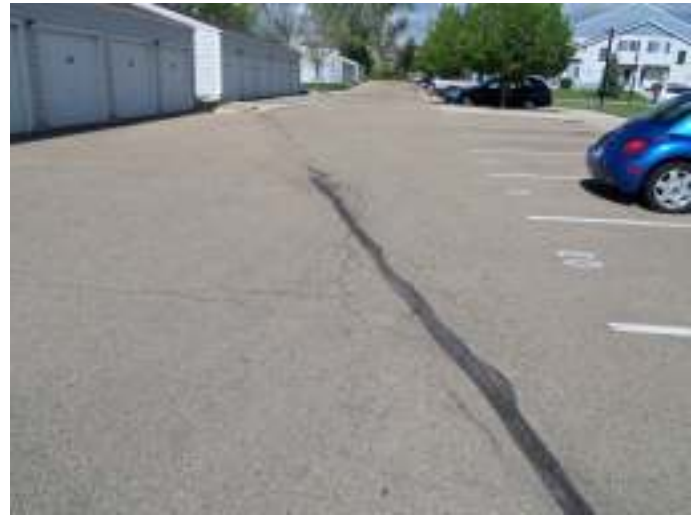
Comp #: 402 Asphalt - Seal Coat/Crack Fill

Asphalt was dry and in need of seal coat this fiscal year. In order to maximize the useful life of the asphalt, it is recommended that the association reserve to seal coat every 3 - 4 years.

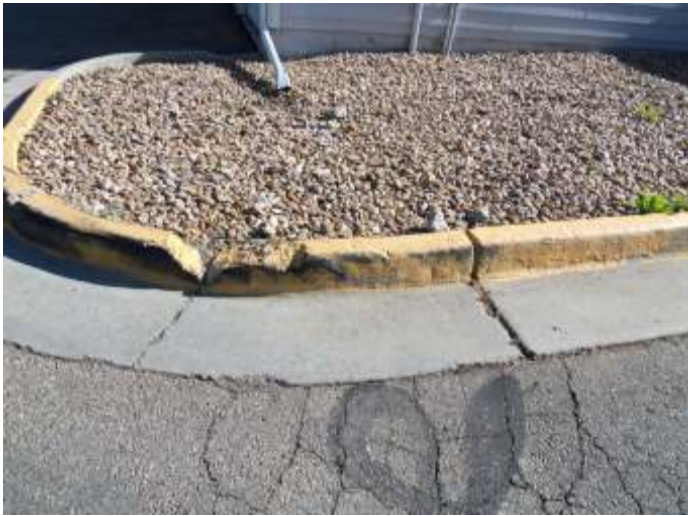
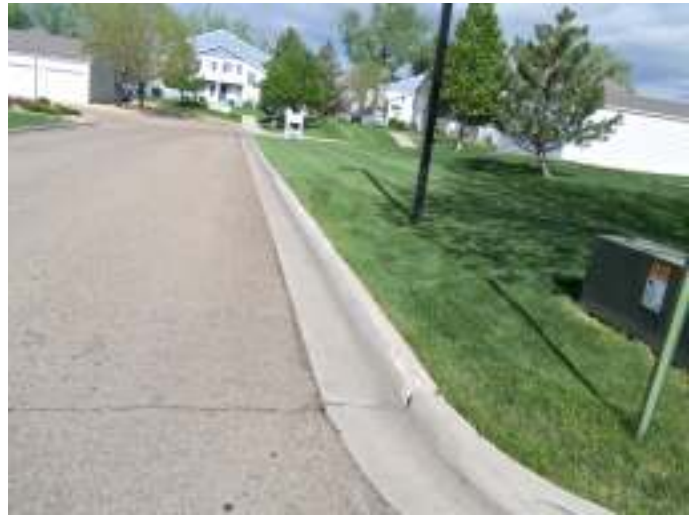
Comp #: 403 Concrete - Repair/Replace

Since it is unlikely that all concrete surfaces will fail at the same time, we suggest establishing a Reserve fund for periodic repairs and replacement to approximately 10% of the total area (860 GSF) every 4 years. Repairs should be coordinated with other concrete surfaces and asphalt for best cost estimate since most asphalt companies can also perform concrete work.

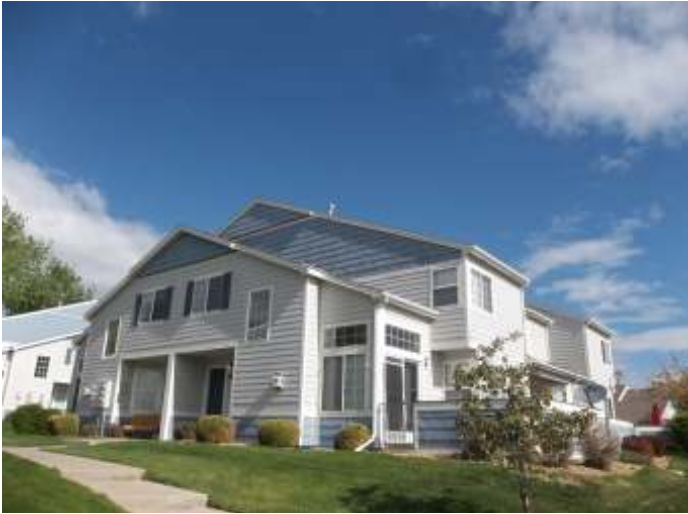
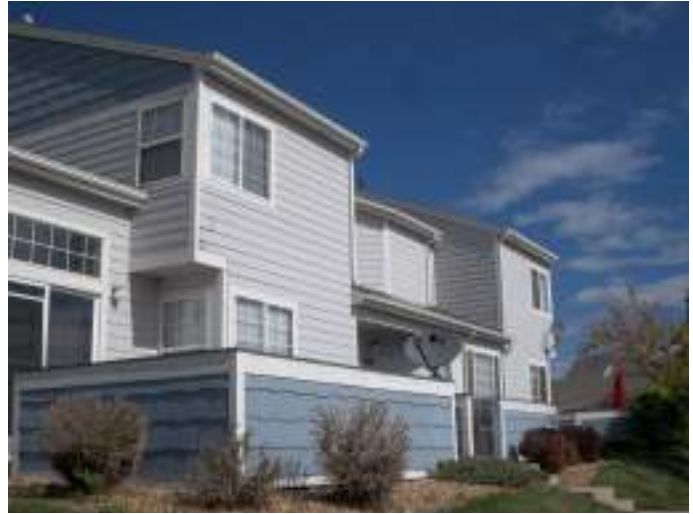
Comp #: 506 Windows and Doors - Replace

At time of preparing this report, it was reported that the replacement of windows and doors is the responsibility of the individual homeowner. We were unable to access the community governing documents at time of report preparation, if the responsibility ends up being the HOA's responsibility, we can add funding upon revision of the draft report.

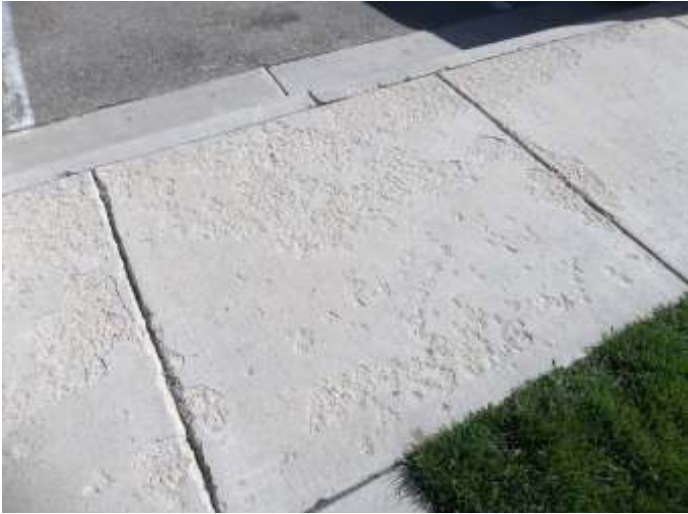
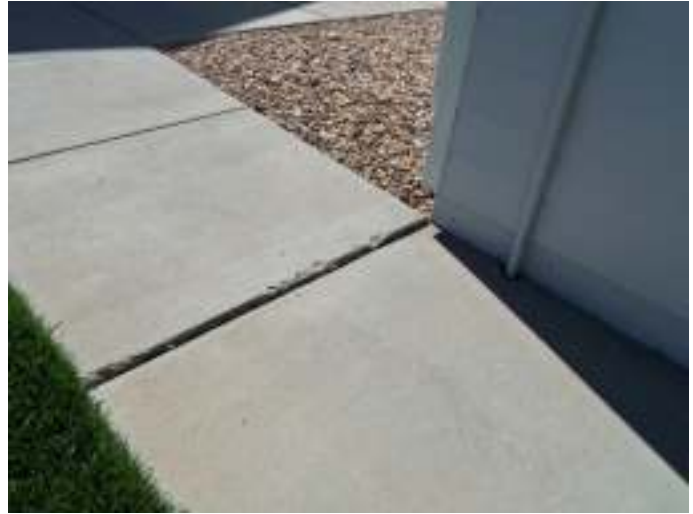
Comp #: 601 Concrete Sidewalks/Patios - Repair

Majority of concrete surfaces appeared in fair condition with only minor areas of cracking noted. Concrete surfaces are subject to minor deterioration, such as spalling and cracking in this climate. However, it is unlikely all concrete surfaces will fail and need to be replaced at the same time. Therefore, we suggest establishing a Reserve allowance for frequent repairs and replacement every 4 years. Coordinate repairs with other concrete surfaces or asphalt for best cost estimate.

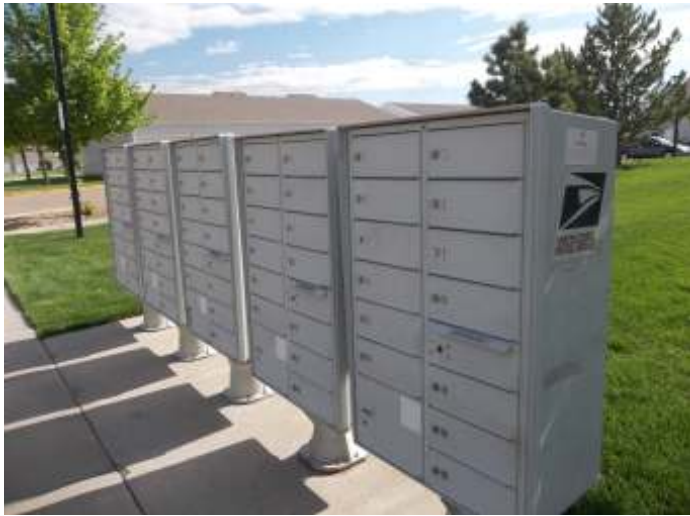
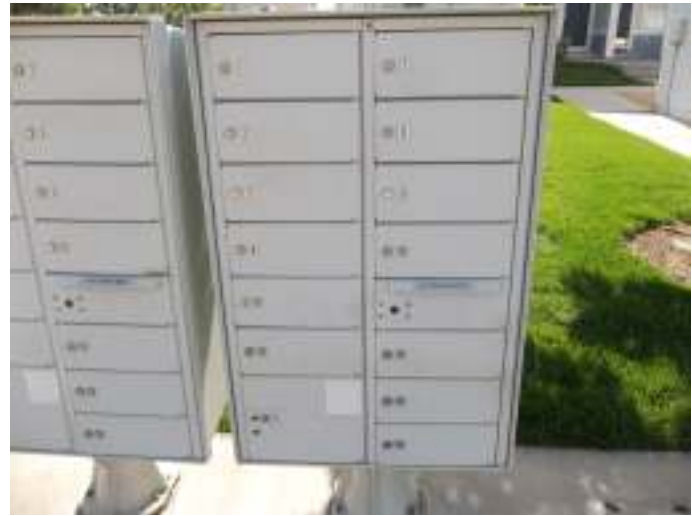
Comp #: 803 Mailboxes - Replace

Mailbox stations are susceptible to rusting at the base where they are anchored into the concrete pad and should be painted as needed using operating funds. According to several manufacturers, the typical life expectancy for this type of mailbox is 15 - 20 years in this environment. Remaining life is based on average age of all units. While it is possible the US Post Office will maintain and replace these boxes in the future, in our experience, we have seen in numerous similar circumstances that the post office makes the association responsible for replacement. This line item is included as a conservative measure in case the post office decides the association is responsible for replacement.

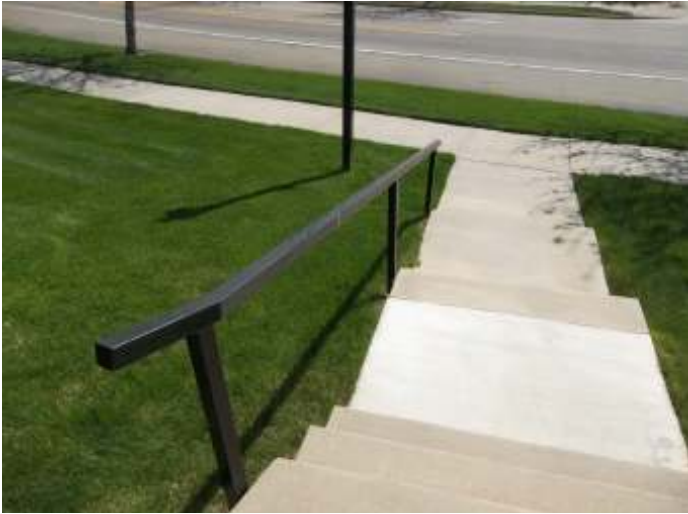
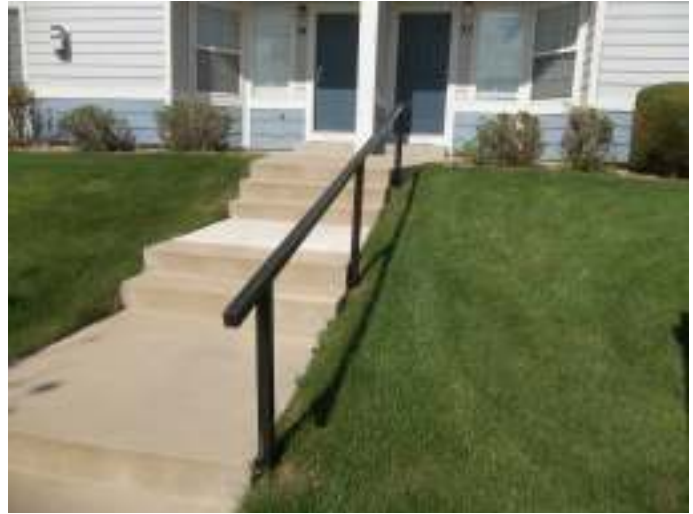
Comp #: 1002 Metal Railings - Replace

The metal rail on site is tube railing and appeared in good condition while on site. Due to the low quantity of railings in the community, we do not recommend reserving to replace or to repaint. Replace and repaint as needed using operating funds. No reserve funding necessary at this time.

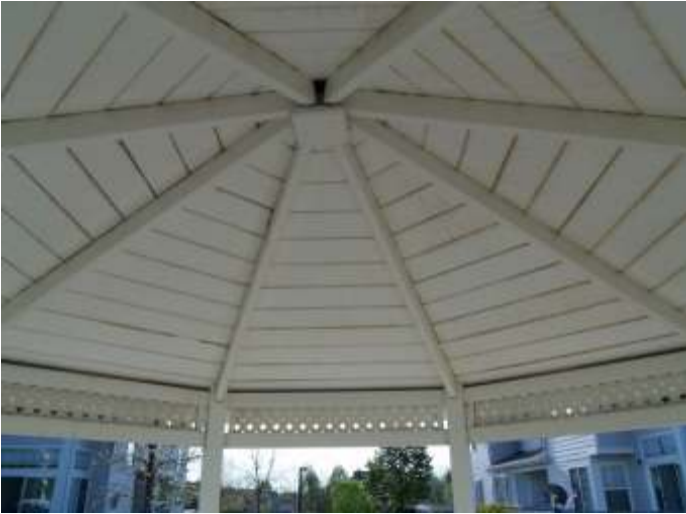
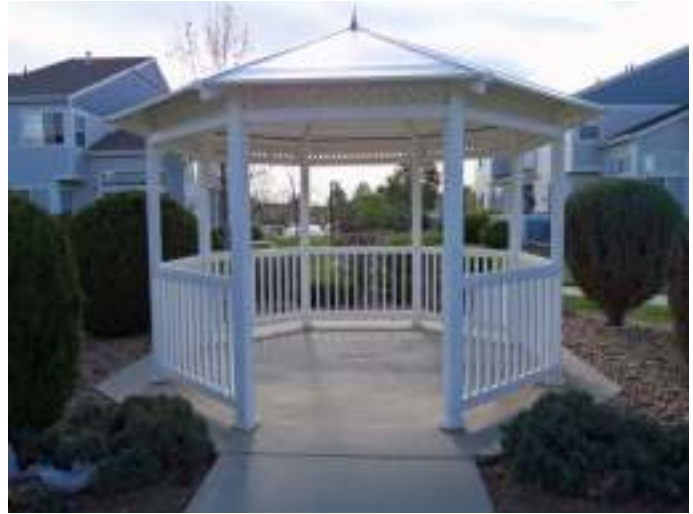
Comp #: 1210 Gazebo - Replace

At time of observation, gazebo appeared stable and in good condition. The gazebo structure should have a useful life of 25 - 28 years before needing to be replaced. Vinyl is a hearty material, however, in this climate, the materials do expand and contract along with the freeze thaw cycle and will eventually need to be replaced due to the vinyl becoming brittle and weak. We recommend reserving to replace the entire gazebo every 25 years to ensure a safe environment as well as to present a proper appearance for the community.

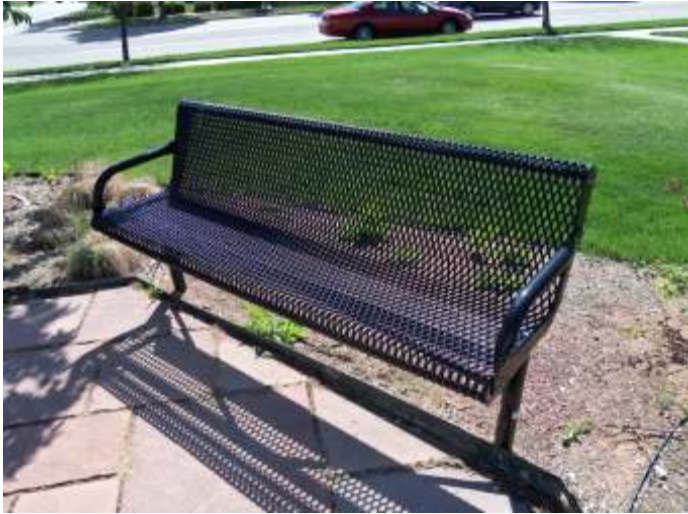
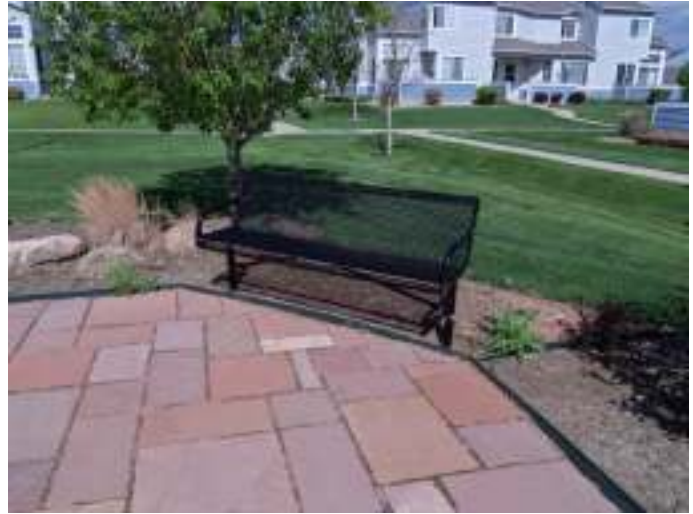
Comp #: 1307 Benches - Replace

Benches appeared in good condition at time of observation with no problems noted with coated surface or stands. Expect to replace benches with this amount of exposure to the elements every 12 - 15 years under normal conditions. Frequently inspect for rust and corrosion and keep metal surfaces painted to maximize the useful life of the benches.

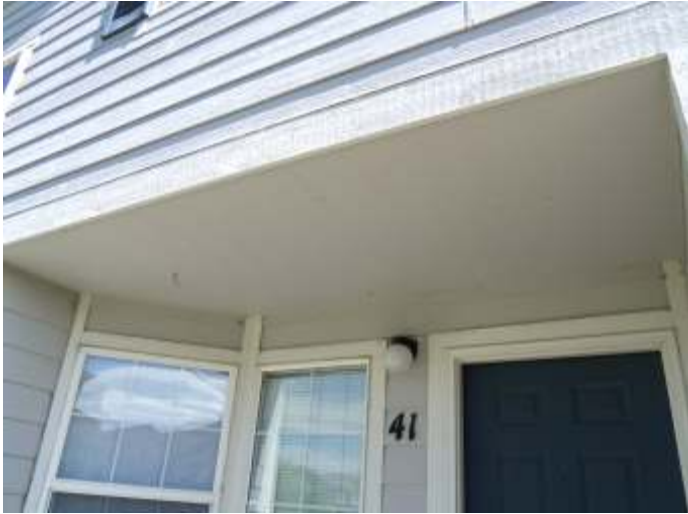
Comp #: 1602 Exterior Wall Mount - Replace

Wall lights appeared aged and in fair to poor condition at time of observation. While replacement can occur on an as needed basis, it is our opinion and recommendation to replace all lights at the same time every 15 - 20 years to maintain a consistent appearance throughout the community. In addition, by replacing multiple fixtures, the association will be able to obtain a quantity discount for the fixtures. Estimated replacement cost includes labor for installation.

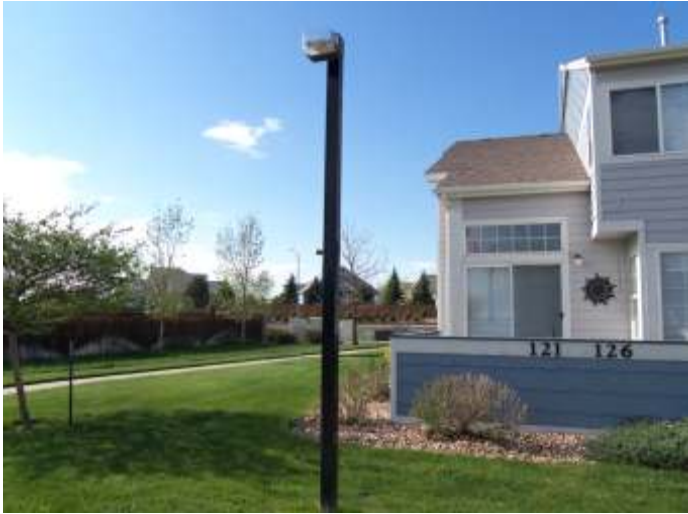
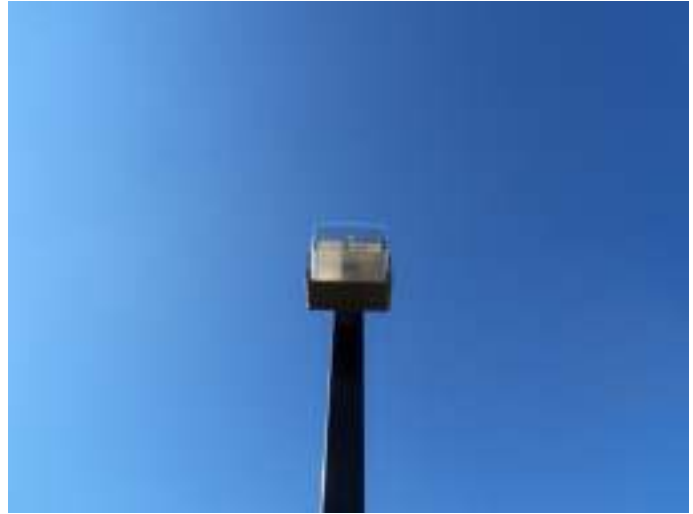
Comp #: 1604 Pole Lights - Replace

Pole lights appeared in fair condition at time of observation and actually appear to be holding up better than what is typically observed in pole lights of this age. We assume these lights were installed at time of construction in 2000/2001 which makes these lights 12 - 13 years old at time of observation. We have extended the useful life a couple of years based on the observed condition. Expect to replace these fixtures every 15 years to maintain a consistent appearance and to ensure proper lighting as a safety precaution for residents.

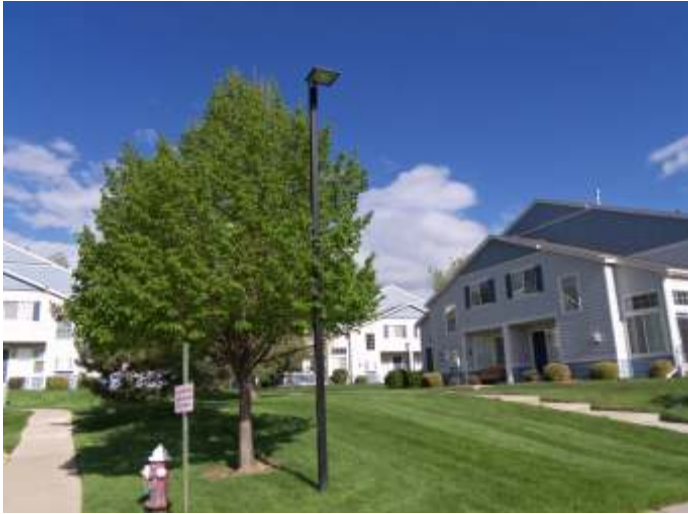
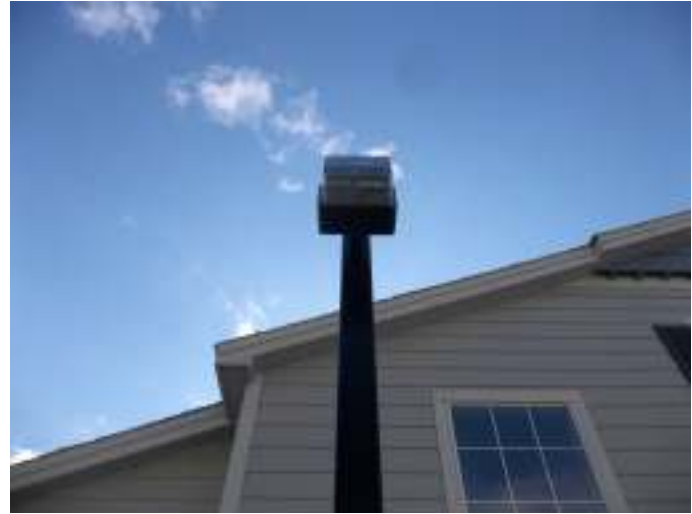
Comp #: 1609 Street Lights - Replace

Similar to the pole lights (comp. #1604) these fixtures appear to be holding up better than what we typically observe in lights of this age (12 - 13 years old). In order to maintain a consistent appearance we recommend replacing all lights at the same time every 18 years.

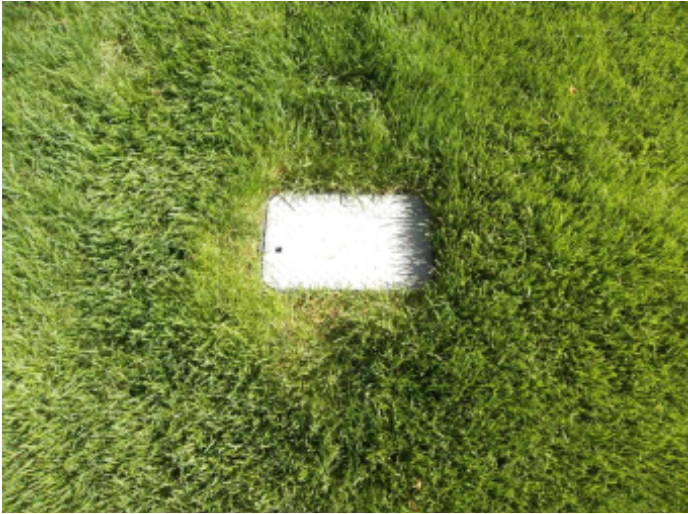
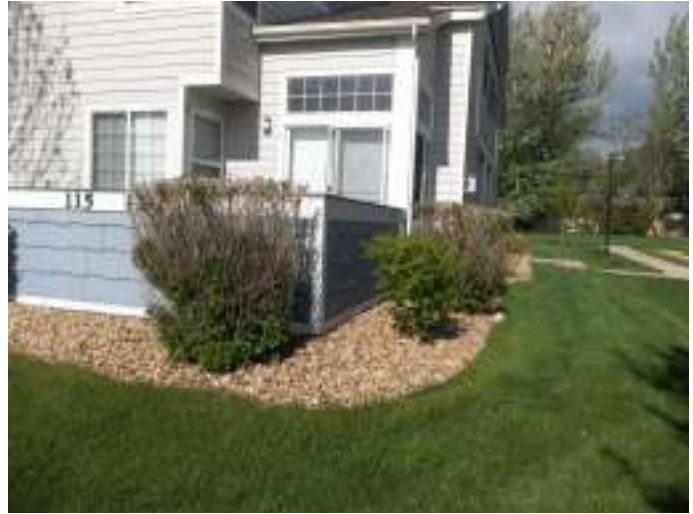
Comp #: 1701 Irrigation System - Major Repairs

At time of observation the irrigation system appeared to have complete coverage with no dry or dead spots in the turf noted. Going forward, it was recommended that the association reserve an allowance for repairs that lie outside the scope of routine maintenance. The system is reportedly installed in a manner that is running into problems along lateral lines that are being impinged upon by maturing tree and shrub roots. These repairs, along with bulk sprinkler head replacement, occasional main line repairs, valve replacement, rewiring, etc. is the reason we are recommending an allowance for major repairs to the system every 3 years.
