**Quail Crossing Townhomes 8708
1419 Red Mountain Drive
Longmont, CO 80504**

Level 1 Reserve Analysis

Report Period – 01/01/14 – 12/31/14

**Date of Property Observation - May 21, 2013
Project Manager - Matthew Woytek
Main Contact Person - Mrs. Francie Orvis, Community Manager**

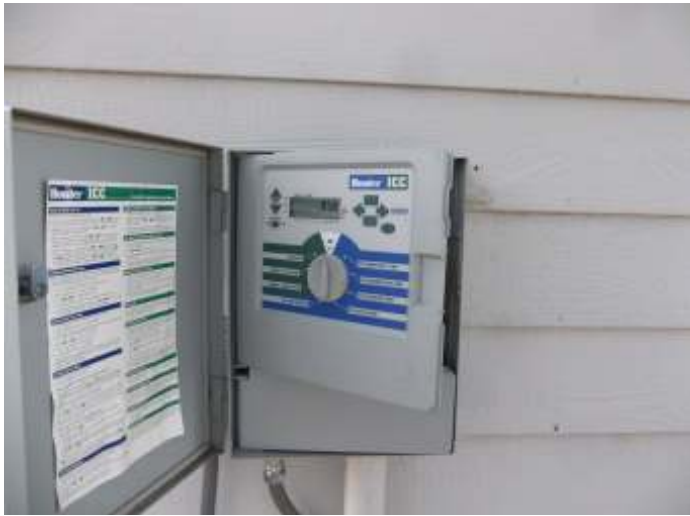
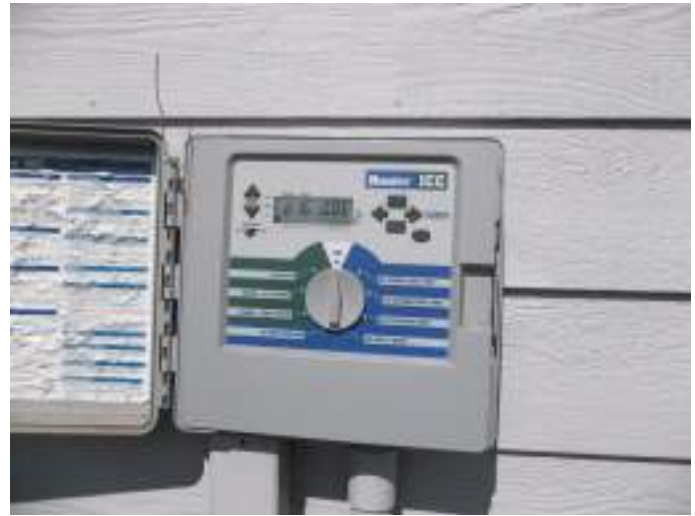
Comp #: 1703 Irrigation Timeclocks - Replace

It was reported at time of preparing this report that the clocks on site are relatively inexpensive and does not reach the minimum cost threshold for separate reserve funding. Therefore, we recommend the association replace the clocks on an as needed basis using operating funds.

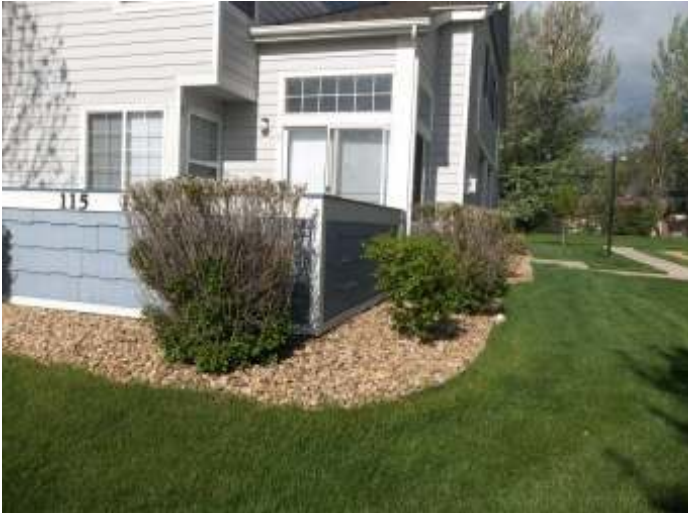
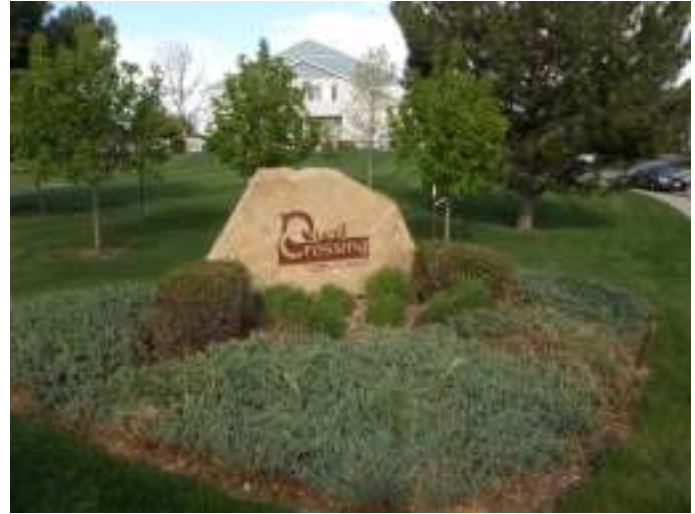
Comp #: 1801 Landscaping - Refurbish

At time of observation and while preparing this report, it was recommended that the association reserve for major landscaping refurbishment to occur every 2 - 3 years. It was reported that the shrubs and plants are struggling to survive and constant maintenance is needed to keep the landscaping in fair condition. Therefore, we recommend reserving to perform refurbishment projects every 3 years. If deterioration rates change, we can adjust cost and/or frequency in future updates of this report.

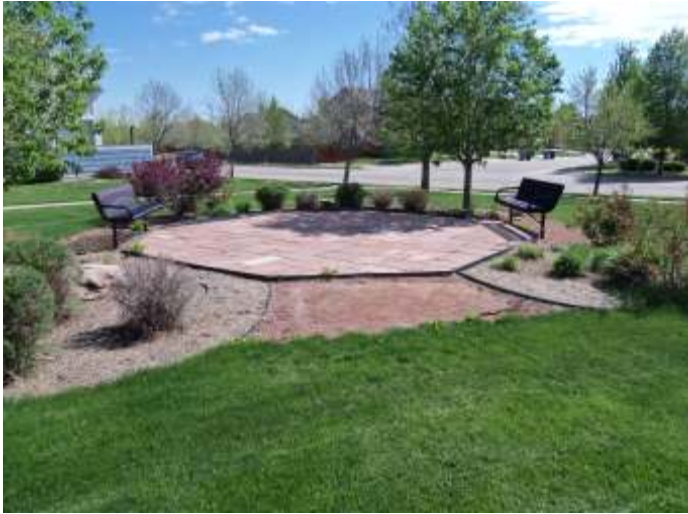
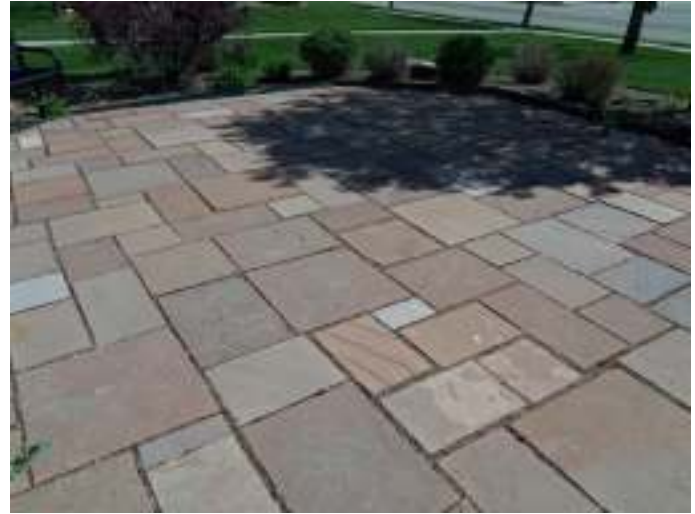
Comp #: 1813 Flagstone - Replace

Flagstone appeared in good condition at time of observation with no overt signs of settling or other problems. The material itself should have a very long useful life and complete replacement is unlikely. We recommend the association frequently inspect the flagstone and repair any settling that may occur. These repairs should be made on an as needed basis using operating funds. No reserve funding is necessary at this time.
