"Full" Reserve Study

Sonoma Village at Ute Creek Longmont, CO

Report #: 32215-0
For Period Beginning: January 1, 2017
Expires: December 31, 2017

Date Prepared: March 8, 2017

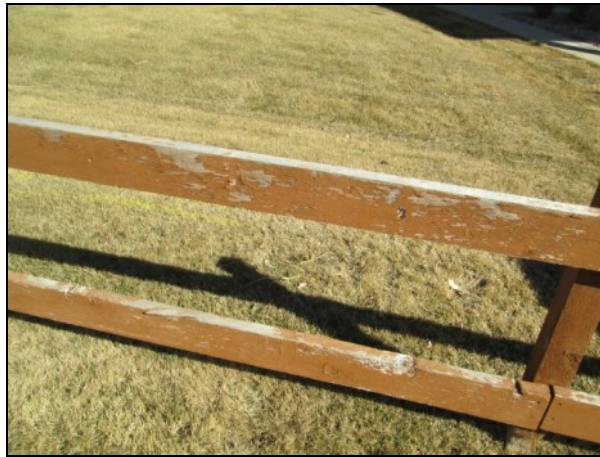
Comp #: 2151 Wood Fences - Repair/Paint

Evaluation: The finish on the wood fence appeared in generally poor condition. Peeling and cracking observed.
