## "Full" Reserve Study

### **Hover Village Seven Community Association Longmont, CO**

**Report #: 36017-0**  
**For Period Beginning: February 1, 2019**  
**Expires: December 31, 2019**

**Date Prepared: April 2, 2019**

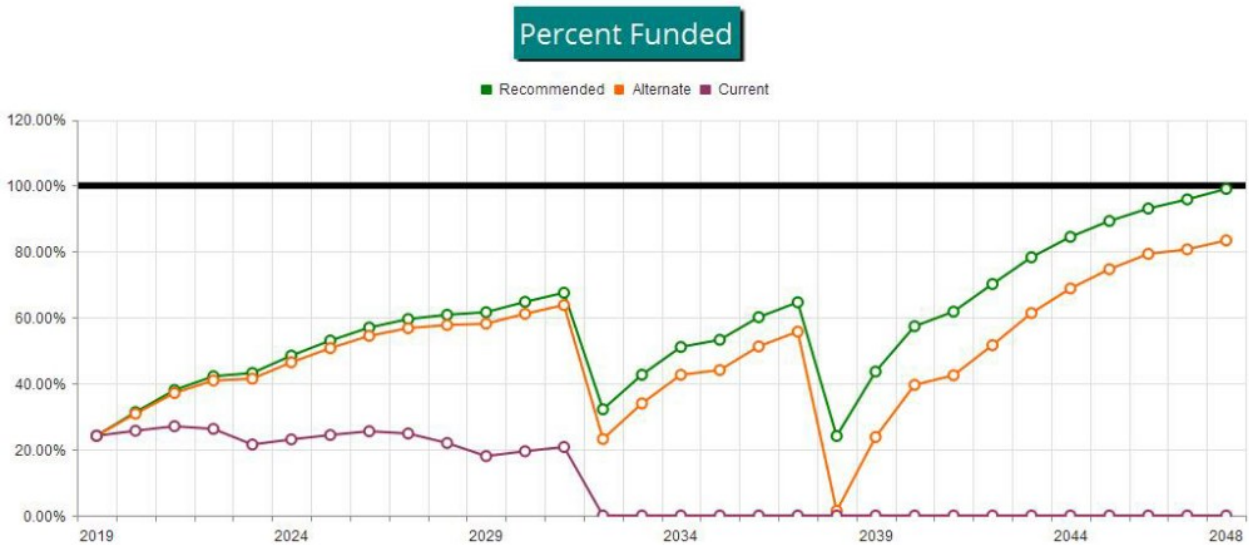
Figure 4

This figure shows the same information plotted on a Percent Funded scale. It is clear here to see how your Reserve Fund strength approaches the 100% Funded level under our recommended multi-yr Funding Plan.

A client that has a percent funded level of <30% may experience an ~ 20%-60% chance risk of special assessment. A client that is between 30% and 70% may experience an ~ 20%-5% chance risk of special assessment. A client that has a percent funded of >70% may experience an ~ <1% chance risk of special assessment.

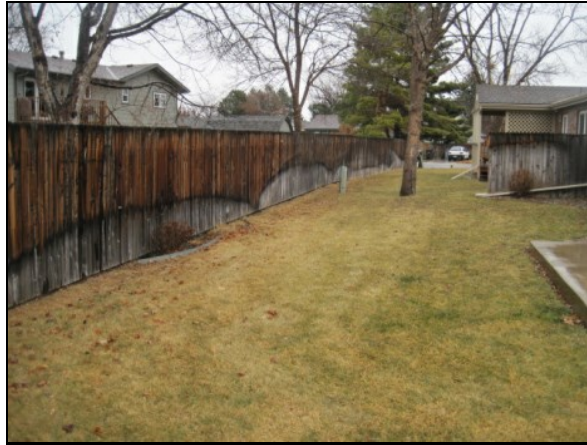
**Comp #: 2155 Site Fencing: Wood - Replace**

Comments: Wood fencing determined to be in fair condition typically exhibits some minor to moderate amounts of surface wear and other signs of age which may include a small percentage of warped split and/or rotted sections. In general appearance is consistent but declining. As routine maintenance inspect regularly for any damage repair as needed and avoid contact with ground and surrounding vegetation wherever possible. Regular cycles of uniform professional sealing/painting will help to maintain appearance and maximize life. In our experience wood fencing will typically eventually break down due to a combination of sun and weather exposure which is sometimes exacerbated by other factors such as irrigation overspray abuse and lack of preventive maintenance. Recommendation and costs shown here are based on replacement with similar style and material. However the client might want to consider replacing with more sturdy lower-maintenance products like composite vinyl etc. Although installation costs are higher total life cycle cost is lower due to less maintenance and longer design life expectancy.

Useful Life:  
20 years

Remaining Life:  
8 years

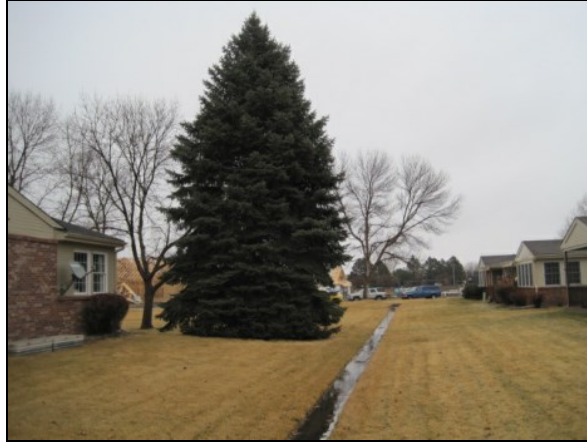
Comments: Funding included at the request of the client. Client also expressed concern over costs of irrigation line replacement however the vendor reported that the system was in fair condition and no reason to expect large scale replacements and continue replacing irrigation lines on an as needed basis. Routine daily/weekly/monthly maintenance is expected to be funded through the Operating budget. However this component represents a supplemental allowance" for larger projects which may occur periodically

Useful Life:  
5 years

Remaining Life:  
2 years

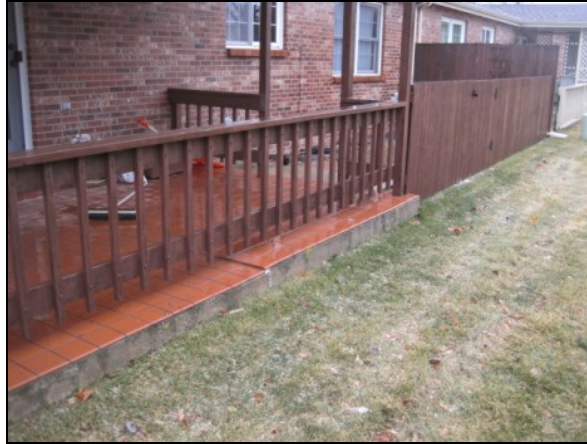
**Comp #:** 2323 Decks/Rails/Trellis - Replace

Comments: All decks and rails are reportedly the individual owners responsibility. If railing is exposed to the elements without adequate coating for an extended period of time useful life may be severely reduced. In general costs related to this component are expected to be included in the client's Operating budget. No recommendation for Reserve funding at this time. However any repair and maintenance or other related expenditures should be tracked and this component should be re-evaluated during future Reserve Study updates based on most recent information and data available at that time. If deemed appropriate for Reserve funding component can be included in the funding plan at that time.

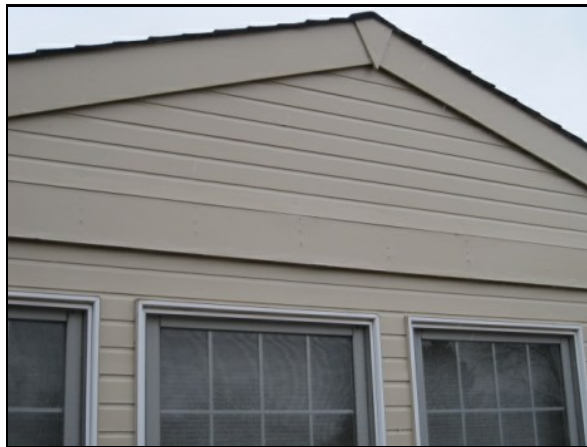
Comments: Painted exterior surfaces determined to be in fair condition typically exhibit some minor to moderate signs of wear and age such as chalking peeling blistering etc. Problems tend to develop in more exposed areas first. Hairline cracks may be present at this stage. Overall appearance is satisfactory. As routine maintenance inspect regularly (including sealants) repair locally and touch-up paint as needed. Typical paint cycles can vary greatly depending upon many factors including type of material painted surface preparations quality of material application methods weather conditions during application moisture beneath paint and exposure to weather conditions. Proper sealant/caulking is critical to preventing water intrusion and resulting damage to the building structure. Incorrect installations of sealant are common and can greatly decrease its useful life. Inspect sealant more frequently as it ages to determine if it is failing. Typical sealant problems include failure of sealant to adhere to adjacent materials and tearing/splitting of the sealant itself. As sealants age and are exposure to ultra-violet sunlight they will dry out harden and lose their elastic ability. Remove and replace sealant as signs of failure begin to appear. Proper cleaning prep work and proper installation are critical for a long lasting sealant/caulking. Do not install sealant in locations that would block water drainage from behind the siding. Repair areas as needed prior to project. For best results the client may want to consult with a building envelope specialist or waterproofing contractor to specify types of materials to be used and define complete scope of work before bidding. Best practice is to coordinate this type of work with other projects whenever practical such as balcony sealing planter waterproofing etc.

Useful Life:  
6 years

Remaining Life:  
3 years

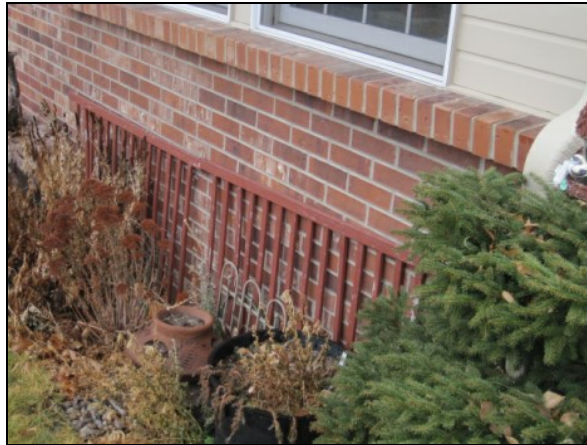
Comments: Brick is typically a low maintenance material that usually requires little maintenance work. After 30-50 years (or more) mortar between brick can require repointing. Repointing involves grinding out small sections of existing mortar and installing new mortar and continuing on until all the mortar has been replaced. As the brick and mortar ages cracking may appear indicating need for repointing. Currently there is no predictable scope or timing for repointing work. Reserve Study review is for financial planning purposes only and if a thorough investigation of brick and mortar is desired we recommend having a masonry specialist inspect the brick and mortar. Funding can be added to future updates to the Reserve Study if scope and timing become more well-defined. No funding suggested at this time.

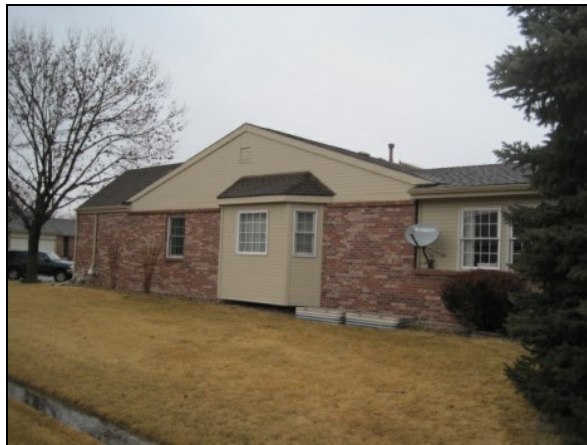
**Comp #: 2353 Wood/Composite Siding - Replace**

Comments: Wood siding determined to be in fair condition typically exhibits some color fading and inconsistency with minor isolated locations showing more advanced surface wear cracking splintering etc. Composite siding is a compressed glued wood fiber material. It is important to paint this type of siding regularly due to its ability to absorb water quickly when the surface is deteriorated or weathered. Once the composite siding takes on water the siding will swell and crack. At next replacement client might want to consider replacing with more sturdy lower-maintenance products. Although installation costs are higher total life cycle cost is lower due to less maintenance and longer design life expectancy.

Useful Life:  
50 years

Remaining Life:  
18 years

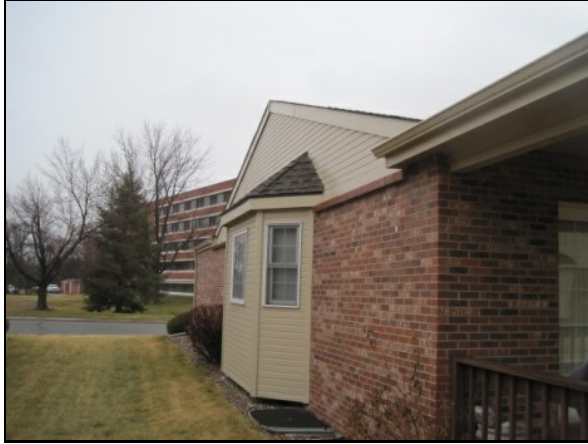
**Comp #: 2361 Windows - Replace**

Comments: Upon review of the client's governing documents individual owners (not the client) appear to be responsible for window replacement. Consult with the client's attorney to determine actual responsibility but based on our review there is no need for Reserve funding.

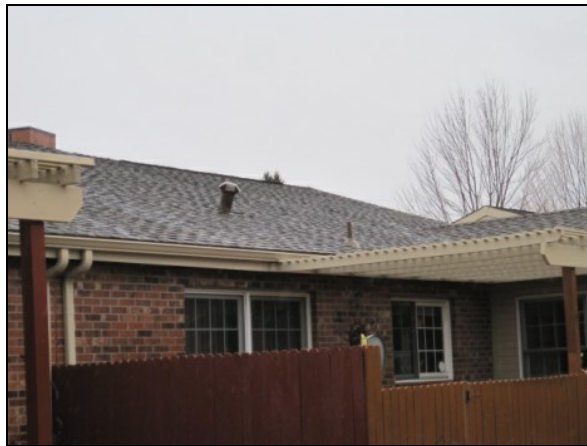
**Comp #: 2377 Roof: Composition Shingle - Replace**

History: Replaced in 2006

Comments: Generally fair condition of roofing system observed during our limited visual review. Closed valleys were observed. Ventilation (the lack of which can greatly reduce the roof's useful life) was observed at the eave and ridge. Eave venting consisted of soffit holes between the rafters. Ridge venting appeared to be provided by roof jacks. Visible portions of roof flashing were observed at the rake headwall and sidewall. Debris was not observed on the roof surface. Asphalt shingle roofs determined to be in fair condition and typically exhibit normal signs of wear and deterioration including some loss of granule cover and light to moderate curling/lifting especially in most exposed areas. Overall believed to be aging normally. A reserve study conducts only a limited visual review and many of the critical waterproofing and ventilation items of the roof are not readily viewable. For a full evaluation have a professional roof consultant/contractor perform a thorough up-close survey of your entire roof system including attic inspection (if any). Costs below factors replacement with an architectural grade laminated shingle. As routine maintenance many manufacturers recommend inspections at least twice annually (once in the fall before the snow season and again in the spring) and after large storm events. Promptly replace any damaged/missing sections or any other repair needed to ensure waterproof integrity of roof. Keep roof surface gutters and downspouts clear and free of debris. At the time of re-roofing we recommend that you hire a professional consultant to evaluate the existing roof and specify the new roof materials/design provide installation oversight. We recommend that all clients hire qualified consultants whenever they are considering having work performed on any building envelope (waterproofing) components including: roof walls windows decks exterior painting and caulking/sealant. There is a wealth of information available through Roofing Organizations such as: National Roofing Contractors client (NRCA) <http://www.nrca.net>. Asphalt Roofing Manufacturers client (ARMA) <http://www.asphaltroofing.org/> Roof Consultant Institute (RCI) <http://www.rci-online.org>

Useful Life:  
25 years

Remaining Life:  
12 years

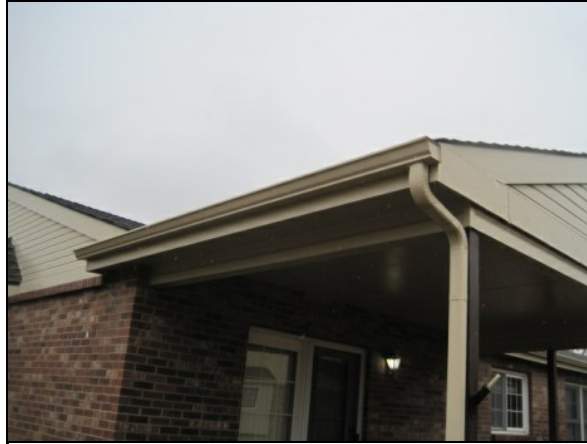
**Comp #: 2387 Gutters/Downspouts - Replace**

History: Replaced in 2006

Comments: Gutters and downspouts determined to be in fair condition typically exhibit some normal wear and tear but drainage away from the roof and building appears to be adequate. Generally believed to be aging normally. Gutters and downspouts are assumed to be functioning properly unless otherwise noted. As routine maintenance inspect regularly keep gutters and downspouts free of debris. If buildings are located near trees keep trees trimmed back to avoid accumulation of leaves on the roof surface which will accumulate in the gutters and increase maintenance requirements while reducing life expectancy. Repair or replace individual sections as needed as an Operating expense. We generally recommend that the gutters and downspouts be replaced when the roof is being resurfaced/replaced. National Roofing Contractor client (NRCA) roofing standard includes installing eave flashings at the gutters. We suggest to plan for total replacement of gutter and downspouts at the same intervals as roof replacement for cost efficiency. Unless otherwise noted costs shown here assume replacement with similar type as are currently in place.

Useful Life:  
25 years

Remaining Life:  
12 years
