“Full” Reserve Study

Spring Valley at Golf Estates Longmont, CO

Report #: 21446-0
For Period Beginning: January 1, 2016
Expires: December 31, 2016

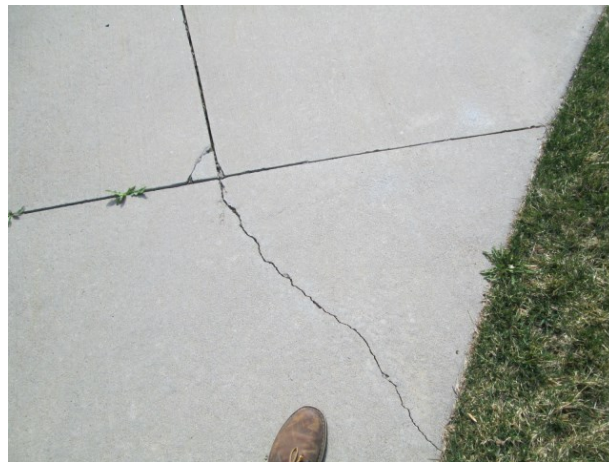
Comp #: 2115 Concrete Walkways - Repair - 5% Quantity: 5% of ~ 12,000 GSF

Evaluation: No major problems noted during the inspection, with minimal spalling and slight cracking observed. Colorado is home to expansive soils. One of the causes of concrete damage is soil moisture. Expansive soils tend to swell in size when wet and contract as they dry out. As the soil expands and contracts it can create enough force to cause major damage to sidewalks. Repair any trip and fall hazards immediately to ensure safety. As routine maintenance, inspect regularly, pressure wash for appearance and repair promptly as needed to prevent water penetrating into the base and causing further damage. In our experience, larger repair/replacement expenses emerge as the community ages. Although difficult to predict timing, cost and scope, we suggest a rotating funding allowance to supplement the operating/maintenance budget for periodic larger repairs. Adjust as conditions, actual expense patterns dictate within future reserve study updates.

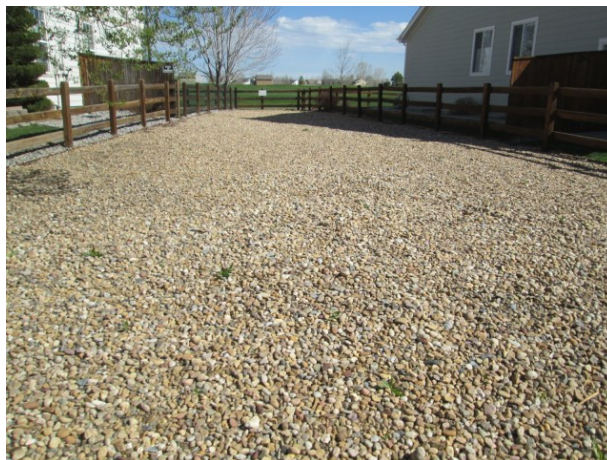
Evaluation: (4) small gravel sections. No issues were noted. Plan to refurbish and replenish as needed from the operating budget.

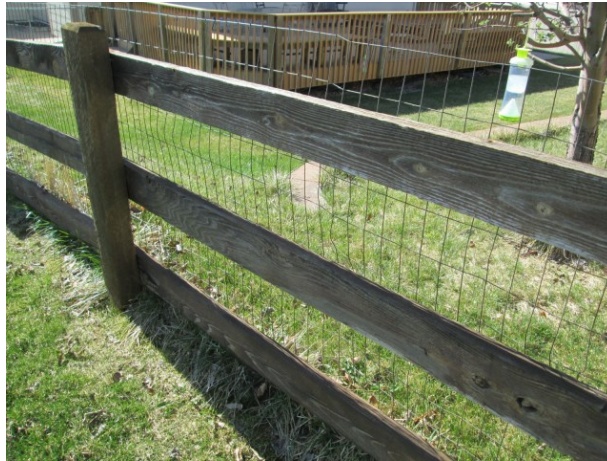
Comp #: 2151 Site Fencing: 3-Rail - Repair/Paint

Useful Life:
5 years

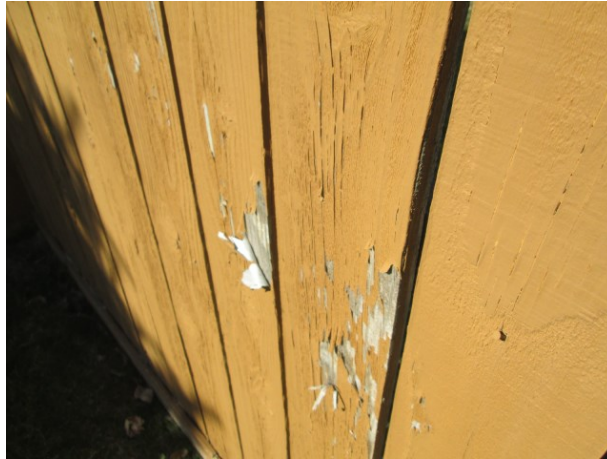
Comp #: 2151 Site Fencing: Privacy - Paint/Stain

Useful Life:
5 years

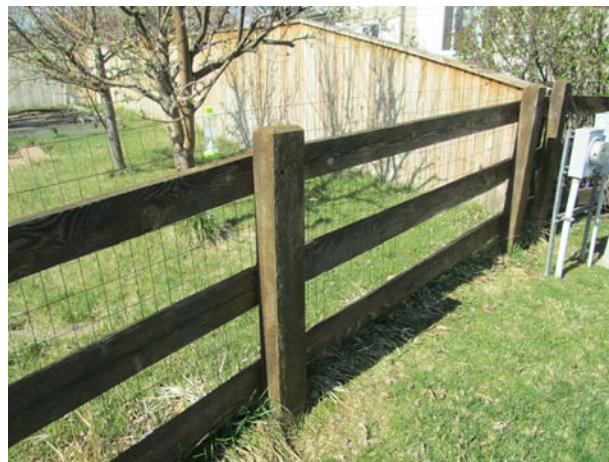
Useful Life:
25 years

Remaining Life:
9 years

Best Case: \$107,200
Lower allowance

Worst Case: \$134,000
Higher allowance

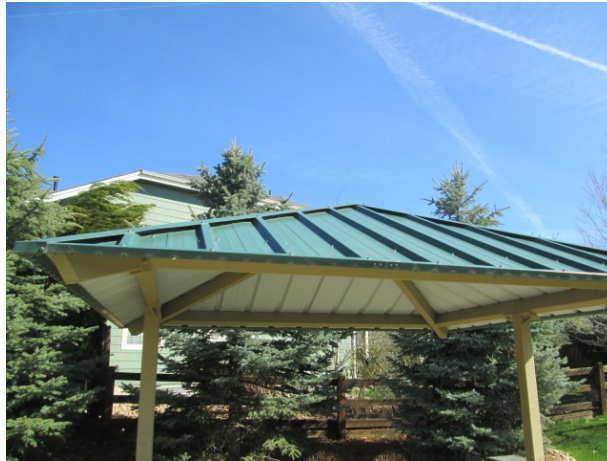
Comp #: 2167 Gazebo Roofs - Replace

Useful Life:
30 years

Remaining Life:
14 years

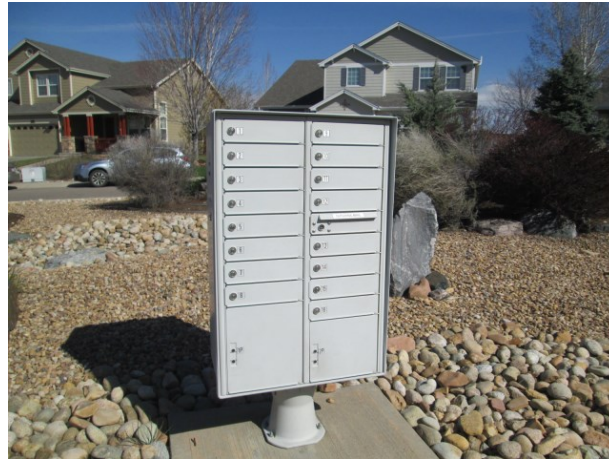
Useful Life:
30 years

Remaining Life:
14 years

Best Case: \$13,200
Lower allowance

Worst Case: \$18,500
Higher allowance

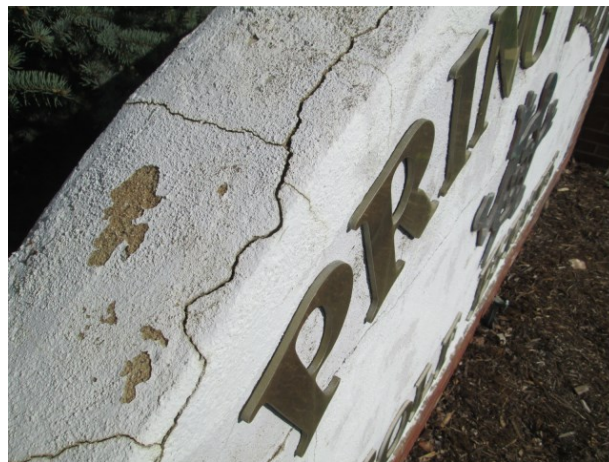
Useful Life: 15 years

Remaining Life:

Best Case: \$5,000 Lower allowance

Worst Case: \$6,000 Higher allowance

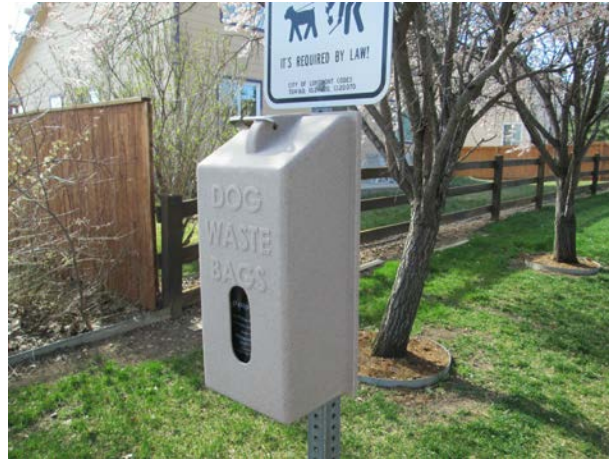
Useful Life:
7 years

Remaining Life:
6 years

Best Case: \$1,000
Lower allowance

Worst Case: \$2,000
Higher allowance

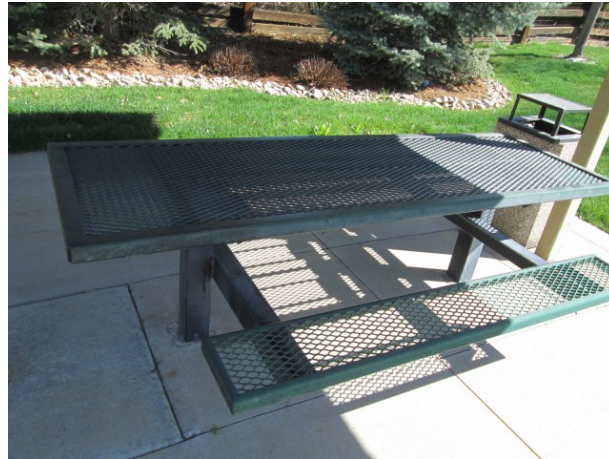
Useful Life:
20 years

Remaining Life:
4 years

Best Case: \$2,400

Worst Case: \$3,500

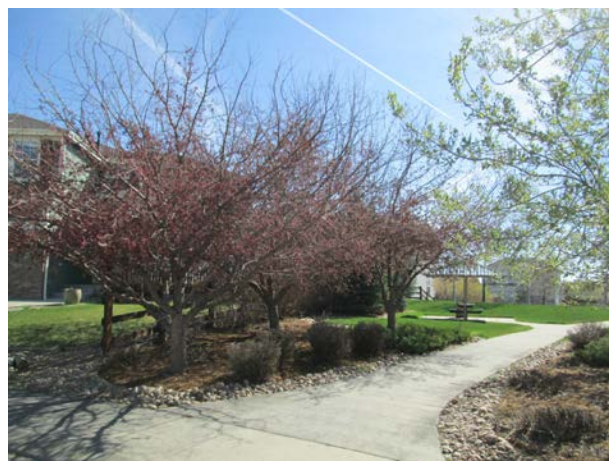
Useful Life:
10 years

Remaining Life:
9 years

Best Case: \$9,000

Worst Case: \$11,000

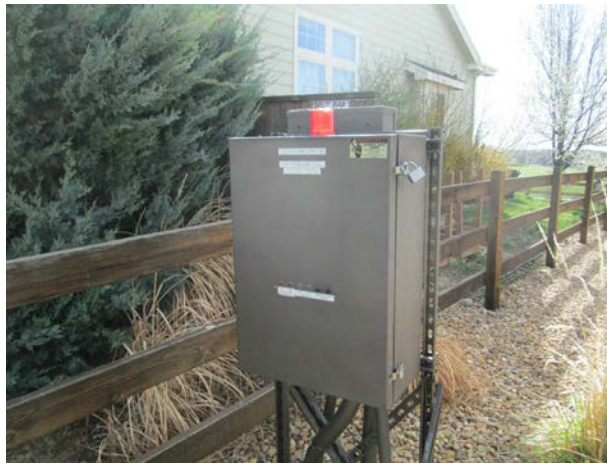
Useful Life:
10 years

Remaining Life:
4 years

<p>Best Case: \$11,300 Lower allowance</p>	<p>Worst Case: \$11,900 Higher allowance</p>
<p>Cost Source: Research with Local Vendor/Contractor</p>

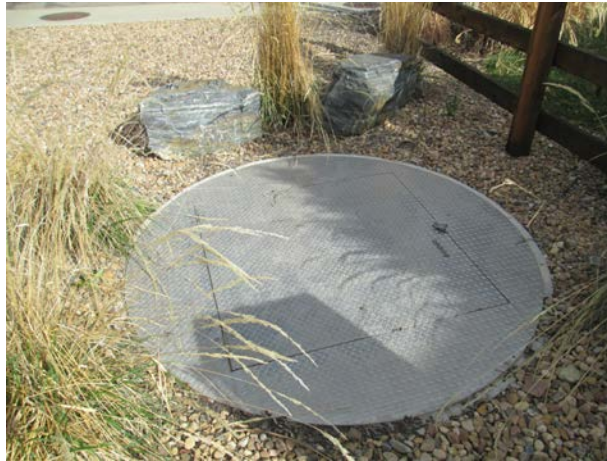
Useful Life:
8 years

Remaining Life:
6 years

Best Case: \$4,500

Worst Case: \$5,500

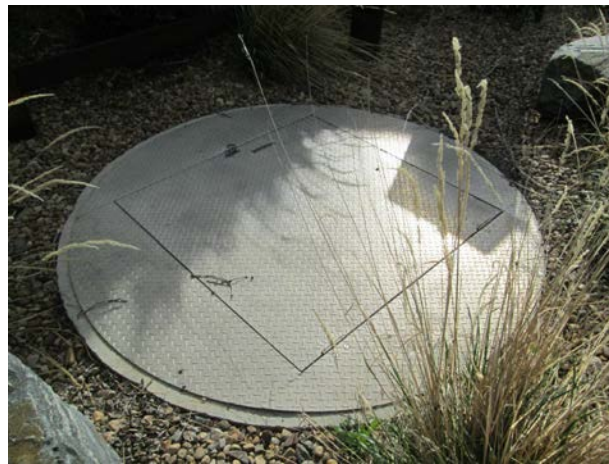
Useful Life:
8 years

Remaining Life:
2 years

Best Case: \$13,500
Lower allowance

Worst Case: \$16,500
Higher allownace

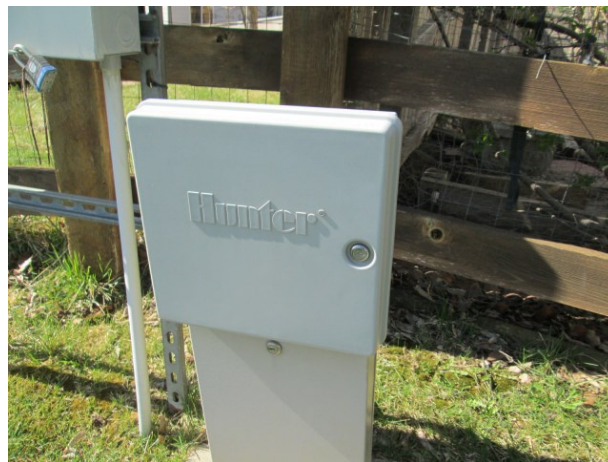
Useful Life:
7 years

Remaining Life:
2 years

Best Case: \$1,000
Lower allowance

Worst Case: \$1,400
Higher allowance

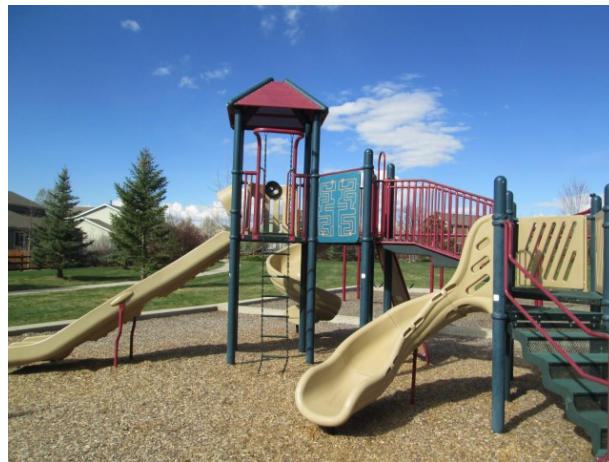
Useful Life:
25 years

Remaining Life:
9 years

Best Case: \$30,000
Lower allowance

Worst Case: \$40,000
Higher allowance

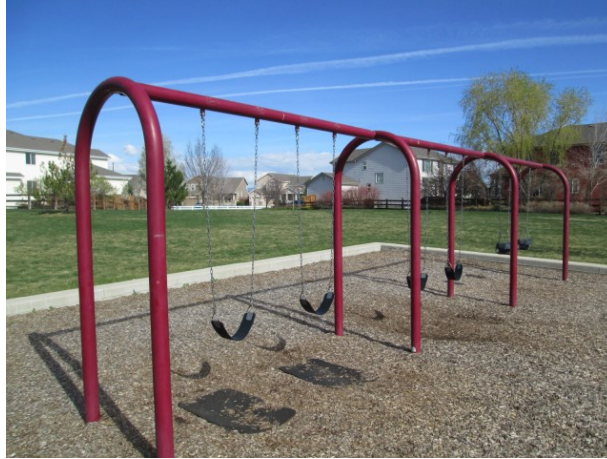
Useful Life:
10 years

Remaining Life:
3 years

Best Case: \$2,500 **Worst Case:** \$4,200
Lower allowance Higher allowance
Cost Source: ARI Cost Database: Similar Project Cost History
