Starwood at Fox Meadow
Stardance Cr.
Longmont, CO 80501

Level 1 Reserve Analysis

Original Reserve Study with Property Inspection

Date of Property Inspection – August 17, 2006
Report Prepared by – G. Michael Kelsen
Property Inspected by - Dan Flack
Main Contact Person - Ms. Gwen Rohrer
Community Manager

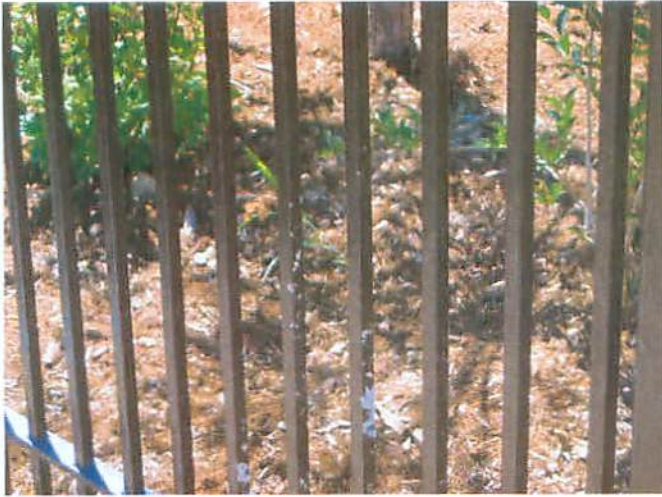
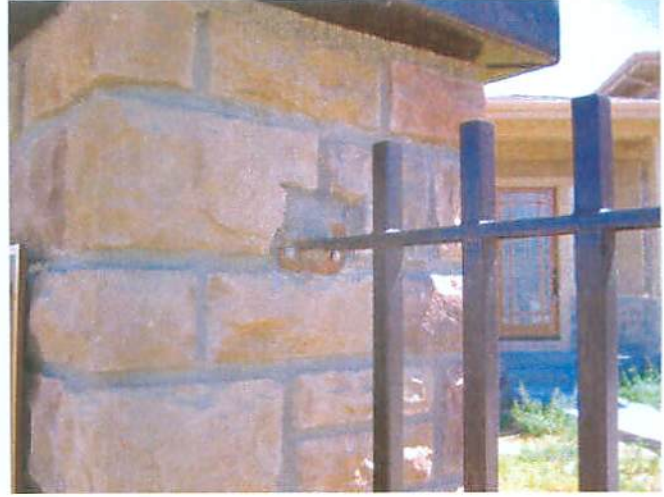
Comp #: 207 Iron Fencing - Repaint

Overall conditions include fading paint, rusting, and general deterioration of painted material. In this climate, metal and iron surfaces should be painted every 3 - 4 years to maintain the appearance and protect the metal materials from rusting and corrosion.

Location: Community entrances

Quantity: Approx. 545 LF

Life Expectancy: 4 *Remaining Life:* 0

Best Cost: \$2,450
\$4.50/LF; Estimate to repaint fence

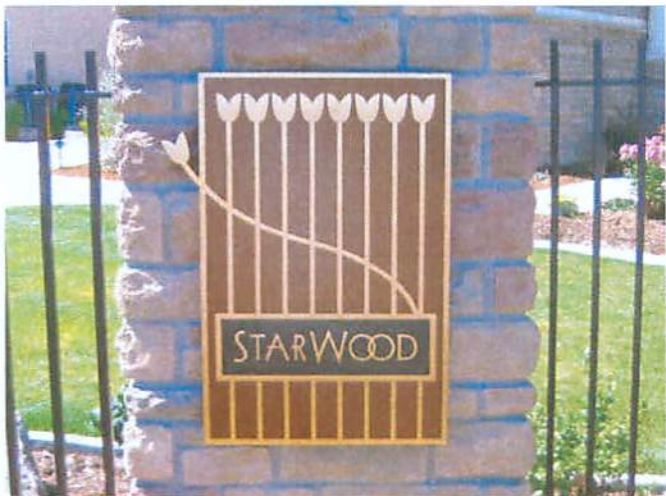
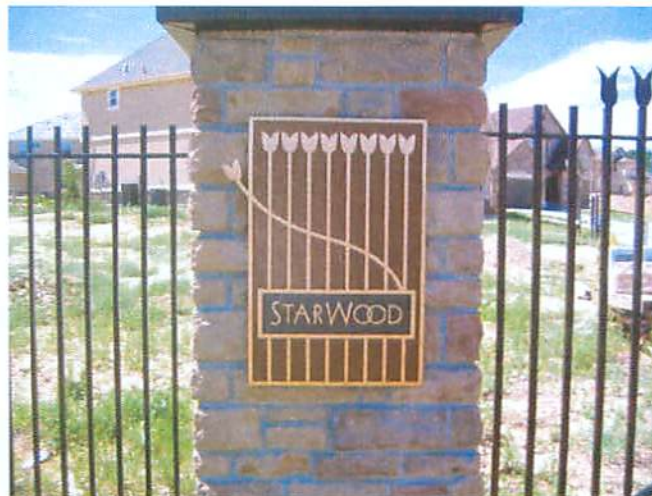
Comp #: 809 Community Signs - Replace

Signs are legible and in good condition with no signs of deterioration or aging. These signs will eventually tarnish and will need some general maintenance, which should be handled as an operating expense. We suggest the association plans on replacing these signs every 15 - 20 years to maintain the appearance of the entrance to the community. The remaining life is based on the age of the signs.

Location: Community Entrances

Quantity: (4) Community Signs

Life Expectancy: 20 *Remaining Life:* 16

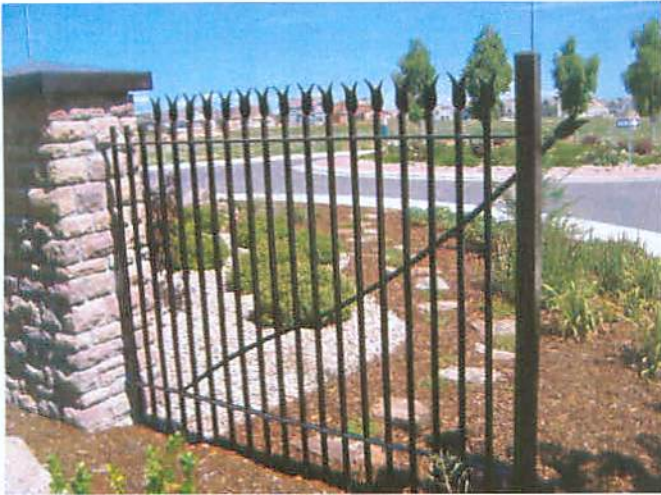
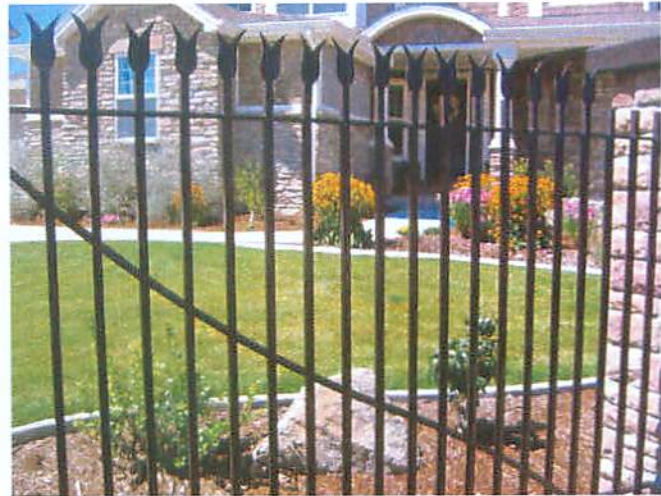
Comp #: 1002 Ironwork Fencing - Replace

Fencing is in good condition with no significant rusting or structural problems noted at the time of inspection. With regular painting and maintenance, expect a useful life of 25 to 30 years in this environment. Remaining life based on current age and observed conditions.

Location: Community entrances

Quantity: Approx. 545 LF

Life Expectancy: 28 *Remaining Life:* 24

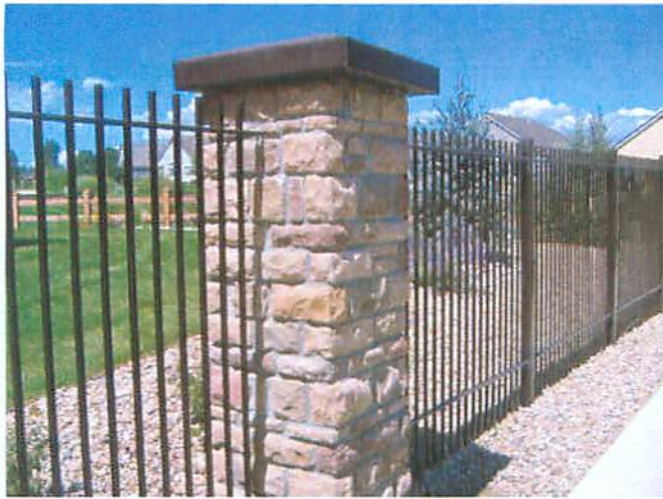
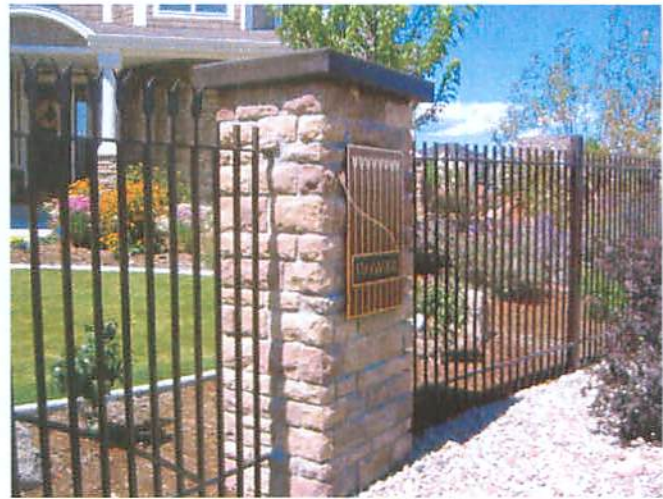
Comp #: 1005 Stone Columns - Replace

All columns were in very good condition with no signs of loose stones at time of inspection. While it is unlikely that the entire column will need to be replaced, it is likely that major repairs will be necessary to replace loose or missing stones. Depending on the effects from weather and potential vandalism, we suggest establishing a Reserve fund for periodic repairs to the pillars every 10 years.

Location: Community entrances

Quantity: Approx. 720 GSF

Life Expectancy: 10 *Remaining Life:* 6

Best Cost: \$7,500

Allowance for general repairs

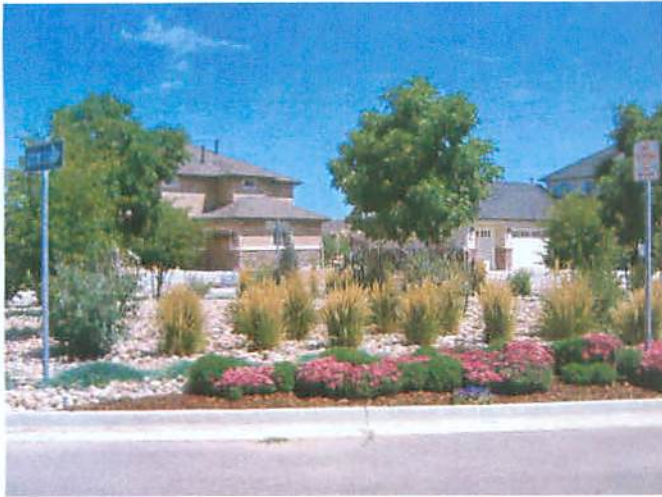
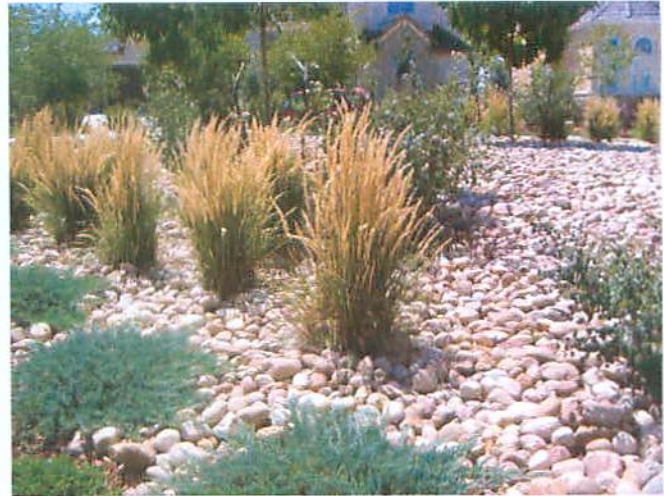
Comp #: 1801 Landscaped Islands - Replenish

No unusual conditions were observed during inspection. Groundcover and plant material is typically replaced on an annual basis with general operating funds. After reviewing the associations budget, it was noticed that \$500 per year is budgeted for plants/trees/shrub replacement. Unless requested by the association, Reserve funding will not be included for this component.

Location: Stardance Way & Orion Court

Quantity: (2) Landscaped Islands
