## "Full" Reserve Study

### **Wolf Creek Owners Association Longmont, CO**

**Report #: 34785-0**  
**For Period Beginning: January 1, 2018**  
**Expires: December 31, 2018**

**Date Prepared: July 12, 2018**

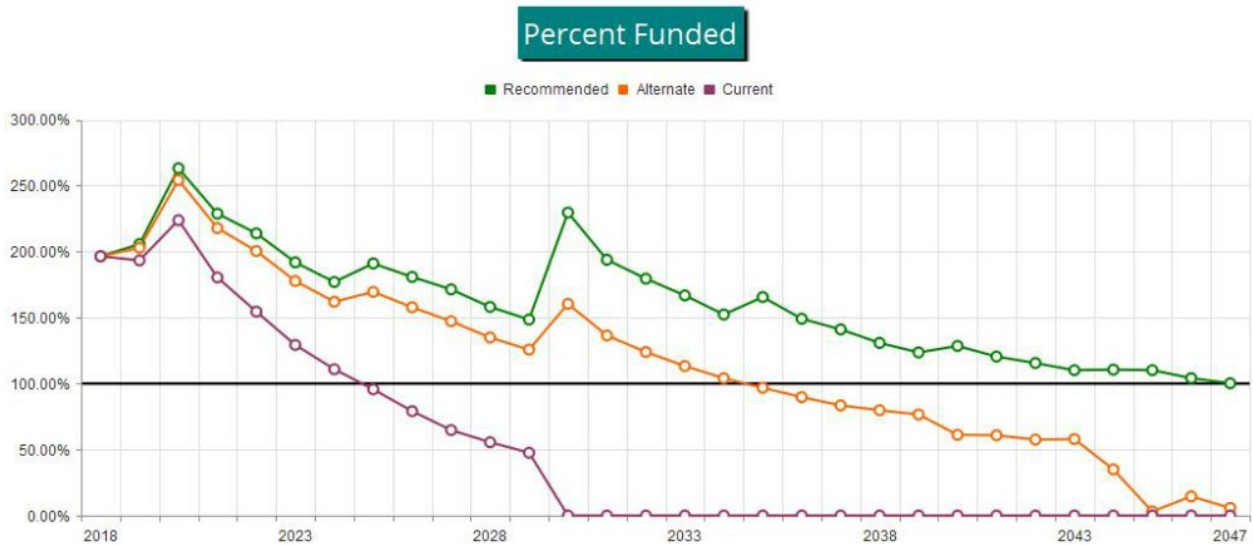
Figure 4

This figure shows the same information plotted on a Percent Funded scale. It is clear here to see how your Reserve Fund strength approaches the 100% Funded level under our recommended multi-yr Funding Plan.

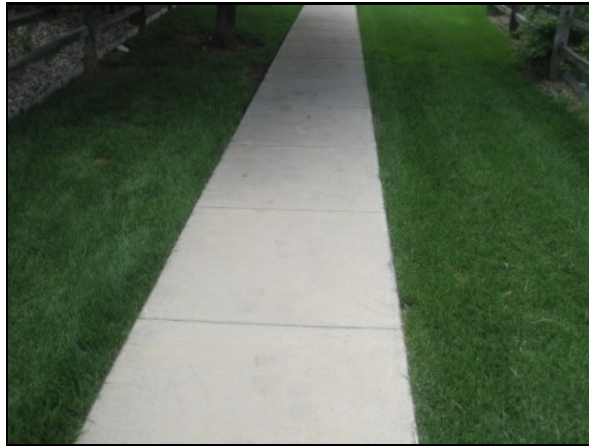
**Comp #: 2115 Concrete Walkways - Repair - 5%**

Evaluation: Concrete sidewalks determined to be in fair condition typically exhibit minor changes in slope and a moderate percentage of cracking and surface wear. Trip hazards may be increasing in frequency and severity and should be closely monitored to prevent further risks. Colorado is home to expansive soils. One of the causes of concrete damage in this type of soil moisture. Expansive soils tend to swell in size when wet and contract as they dry out. As the soil expands and contracts it can create enough force to cause major damage to sidewalks. Repair any trip and fall hazards immediately to ensure safety. As routine maintenance inspect regularly pressure wash for appearance and repair promptly as needed to prevent water penetrating into the base and causing further damage. In our experience larger repair/replacement expenses emerge as the community ages. Although difficult to predict timing cost and scope we suggest a rotating funding allowance to supplement the operating/maintenance budget for periodic larger repairs. Adjust as conditions actual expense patterns dictate within future reserve study updates.

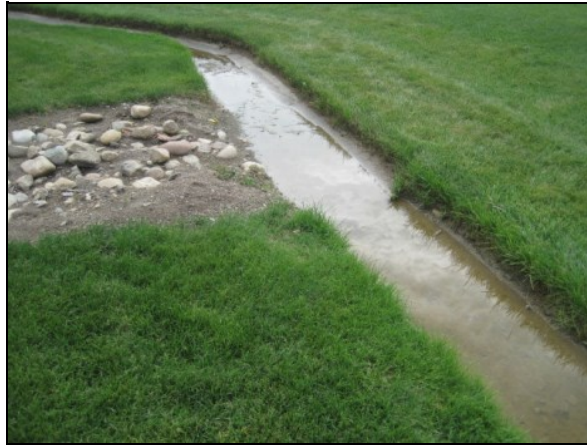
**Comp #: 2117 Site Drainage System - Clean/Repair**

Evaluation: No access to inspect in-ground drainage infrastructure. Annual preventive maintenance work is typically performed as part of an Association's general maintenance/operating fund. Under normal circumstances site drainage components are constructed of very durable materials which should have a very long useful life (often assumed to be 50 years or more). Repairs may occasionally be required but timing and scope of work is too unpredictable for Reserve funding in accordance with National Reserve Study Standards. If there are specific known concerns with drainage system we recommend further investigation using cameras or other means to document and identify conditions. Some Associations consult with civil and/or geotechnical engineers in order to develop scopes of work for repair/replacement. If more comprehensive analysis becomes available findings should be incorporated into Reserve Study updates as appropriate.

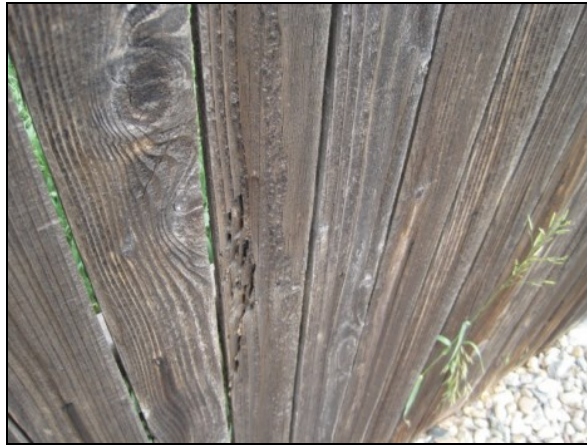
**Comp #: 2151 Site Fencing: Wood - Repair/Paint**

Evaluation: Recommend starting paint cycle after the replacement of fencing. Wood fencing determined to be in poor condition typically exhibits more advanced deterioration of coating with notable wear possibly resulting in rotting of wood structure in places. Poor inconsistent curb appeal. Regular uniform professional paint or sealer applications are recommended for appearance protection of wood and maximum design life. Repair as needed and clean prior to application. Plan for regular applications as shown below. Timing of repair/paint cycles may need to be coordinated with eventual fence replacement.

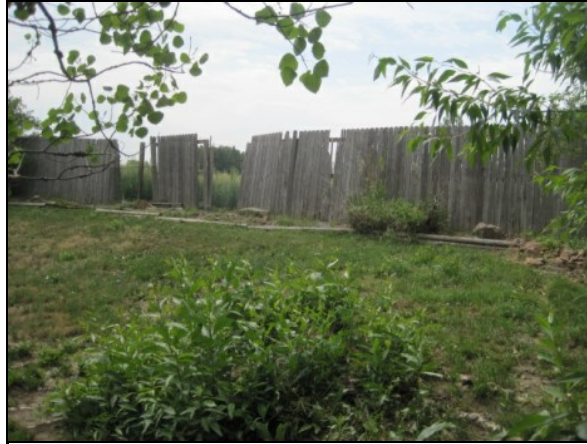
**Comp #: 2155 Site Fencing: Wood - Replace**

Evaluation: Wood fencing determined to be in poor condition typically exhibits more advanced or extensive surface wear and other signs of age which may include damaged or vandalized sections loose or missing hardware and other obvious concerns. At this stage fencing is often an eyesore and replacement from an aesthetic standpoint should be considered even if fencing is still technically upright and intact. As routine maintenance inspect regularly for any damage repair as needed and avoid contact with ground and surrounding vegetation wherever possible. Regular cycles of uniform professional sealing/painting will help to maintain appearance and maximize life. In our experience wood fencing will typically eventually break down due to a combination of sun and weather exposure which is sometimes exacerbated by other factors such as irrigation overspray abuse and lack of preventive maintenance. Recommendation and costs shown here are based on replacement with similar style and material. However the Association might want to consider replacing with more sturdy lower-maintenance products like composite vinyl etc. Although installation costs are higher total life cycle cost is lower due to less maintenance and longer design life expectancy.

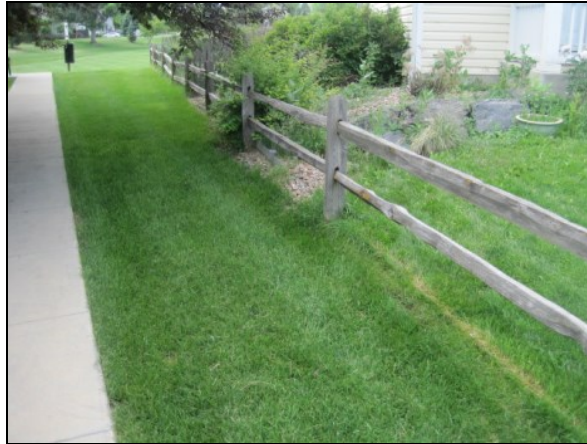
**Comp #: 2157 Fencing: Split Rail - Replace - 20%**

Evaluation: Funding is to begin replacing the fence with a rotating allowance, it is not anticipated to replace all of the fencing at once. Fence is rustic in appearance and will maintain its aesthetic value even with visible signs of deterioration. Wood fencing determined to be in fair condition typically exhibits some minor to moderate amounts of surface wear and other signs of age which may include a small percentage of warped split and/or rotted sections. In general appearance is consistent but declining. As routine maintenance inspect regularly for any damage repair as needed and avoid contact with ground and surrounding vegetation wherever possible. Regular cycles of uniform professional sealing/painting will help to maintain appearance and maximize life. In our experience wood fencing will typically eventually break down due to a combination of sun and weather exposure which is sometimes exacerbated by other factors such as irrigation overspray abuse and lack of preventive maintenance. Recommendation and costs shown here are based on replacement with similar style and material. However the Association might want to consider replacing with more sturdy lower-maintenance products like composite vinyl etc. Although installation costs are higher total life cycle cost is lower due to less maintenance and longer design life expectancy.

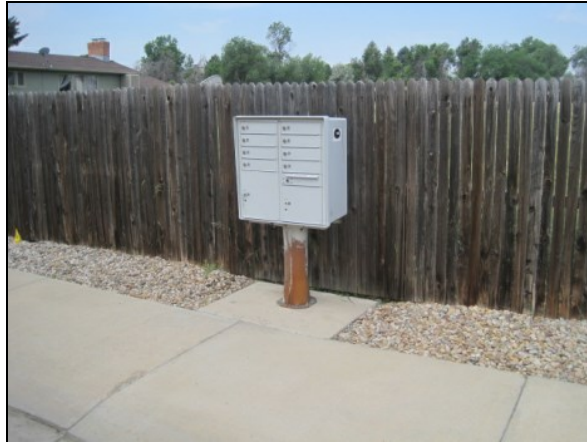
**Comp #: 2179 Mailboxes - Replace**

Evaluation: Rust noted on pedestal. Mailbox kiosks determined to be in fair condition typically exhibit minor to moderate surface wear at this stage. All components and hardware appear to function properly but appearance is diminishing. Inspect regularly and clean by wiping down exterior surfaces. If necessary change lock cylinders lubricate hinges and repair as an Operating expense. Best to plan for total replacement at roughly the time frame below due to constant exposure usage and wear over time. Note USPS has a limited budget for replacement and should not be relied upon for purposes of long term planning.

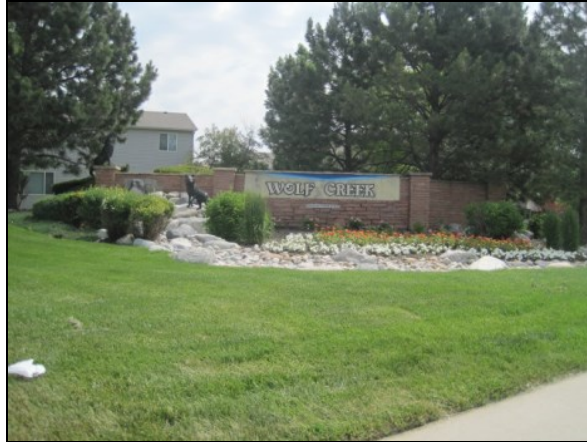
**Comp #: 2181 Sign/Monument - Refurbish/Replace**

Evaluation: Monument signage determined to be in fair condition typically exhibits acceptable appearance and aesthetics in keeping with local area but with more weathering and wear showing on surfaces. If present landscaping and lighting are still in serviceable condition. At this stage signage may be becoming more dated and diminishing in appeal. As routine maintenance inspect regularly clean/touch-up and repair as an Operating expense. Plan to refurbish or replace at the interval below. Timing and scope of refurbishing or replacement projects is subjective but should always be scheduled in order to maintain good curb appeal. In our experience most Associations choose to refurbish or replace signage periodically in order to maintain good appearance and aesthetics in keeping with local area often before signage is in poor physical condition. If present concrete walls are expected to be painted and repaired as part of refurbishing but not fully replaced unless otherwise noted. Costs can vary significantly depending on style/type desired and may include additional costs for design work landscaping lighting water features etc. Reserve Study updates should incorporate any estimates or information collected regarding potential projects.

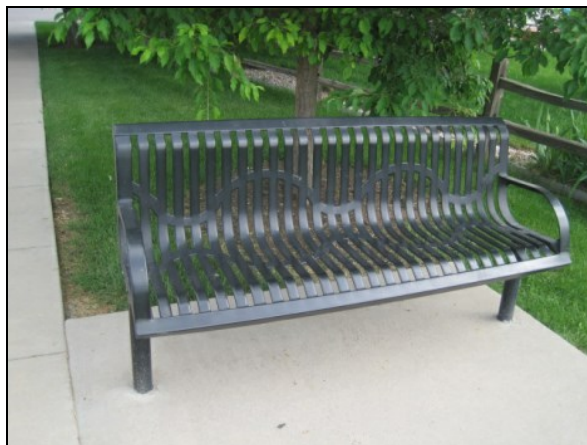
**Comp #: 2191 Outdoor/Site Furniture - Replace**

Evaluation: Outdoor/site furniture determined to be in good condition typically exhibits little to no significant signs of wear or age. Style is attractive and appropriate for the local aesthetic standards of the development. Inspect regularly, clean for appearance and repair as needed from general Operating funds. Cost to replace individual pieces may not meet threshold for Reserve funding. We recommend planning for regular intervals of complete replacement at the time frame indicated below, to maintain a good, consistent appearance in the common areas. Costs shown are based on replacement with comparable types unless otherwise noted.

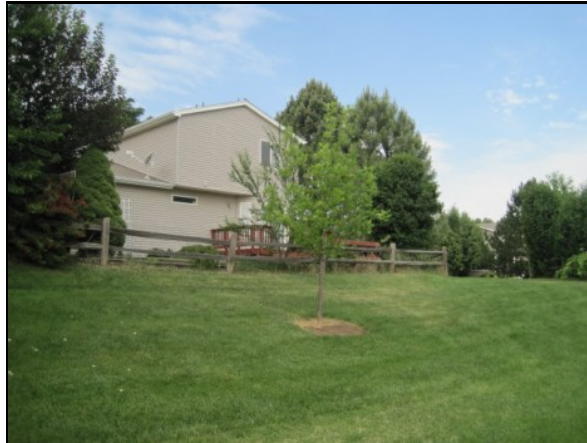
Evaluation: Client requested a one time cost for the replacement of trees due to the invasive asian ash bore. This component may be utilized for larger tree removal/trimming projects which do not occur on an annual basis. If the community has not already done so consult with a qualified arborist or other landscaping professional for a long term plan for the care and management of the trees within the community balancing aesthetics with protection of Association assets. Reserve funding recommend at level indicated below for periodic larger tree removal/trimming needs. Track actual expenses and adjust in reserve study updates if needed.

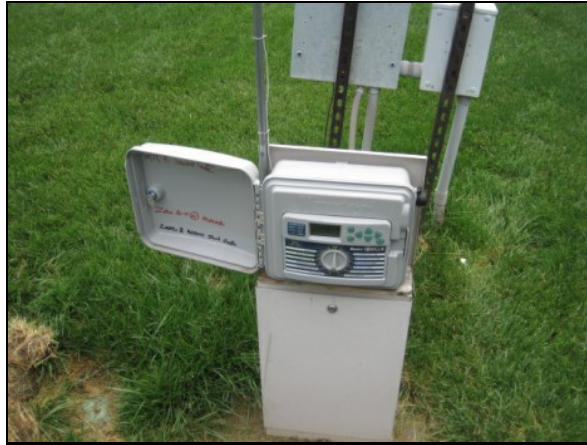
**Comp #: 2581 Irrigation Clocks - Replace - 33%**

Evaluation: Minimal or no subjective/aesthetic value for this component. Useful life is based primarily on normal expectations for service/performance life in this location. Unless otherwise noted remaining useful life expectancy is based primarily on original installation or last replacement/purchase date our experience with similar systems/components and assuming normal amount of usage and good preventive maintenance. Irrigation controllers should have a relatively long life expectancy under normal circumstances. Replacement is often required due to lack of available replacement parts lightning strikes etc. as opposed to complete failure of existing equipment. Exposure to the elements can affect overall life expectancy and controllers should be located in protected areas or within protective enclosures whenever possible. When evaluating replacement options the Association should consider replacement with smart" models (i.e. respond to projected weather data) to minimize unnecessary water usage. Payback period for efficient controllers that minimize water use is typically very short
