"Full" Reserve Study

Sonoma Village at Ute Creek Longmont, CO

Report #: 32215-0
For Period Beginning: January 1, 2017
Expires: December 31, 2017

Date Prepared: March 8, 2017

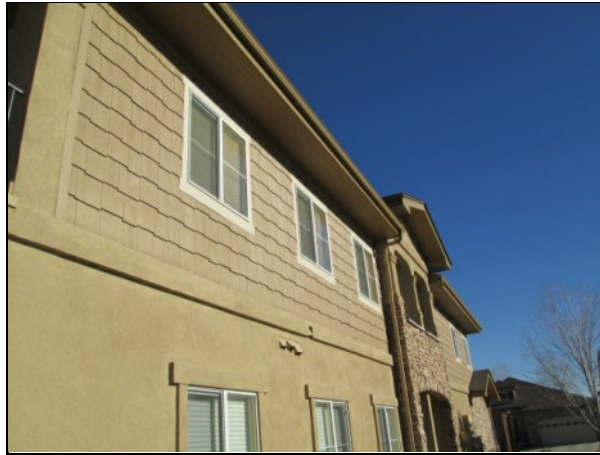
Comp #: 2351 Fiber Cement Siding -Replace (Ph 3)

Evaluation: No major issues were noted at the time of the inspection. Siding was horizontal clapboard as well as shingled siding. Surface was painted. Actual material of siding was not confirmed since we conducted only a limited visual review. Siding is believed to be fiber cement. The largest manufacturer of fiber cement siding is James Hardie Building Products, Inc., and www.jameshardie.com is a good source of information for best practices related to installation, care and maintenance of the product. At this time, there is no well-defined limit to the useful life of fiber cement siding. The association should review any available warranty documents to ensure proper steps are taken to maintain applicable warranties. As the product ages, the association should conduct more detailed inspections beyond the scope of the visual inspection conducted during this engagement. Currently Hardie offers the choice of a 30-year non-prorated or 50-year pro-rated warranty. The underlying waterproofing will degrade over time and may require replacement. No view of underlying waterproofing was part of our limited visual review. Plan for eventual replacement at roughly the time frame below. Inspect and repair as needed using operating and maintenance funds.

Useful Life:
50 years

Remaining Life:
43 years

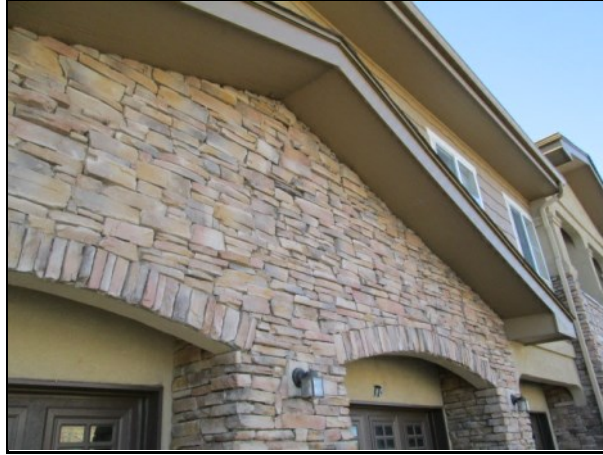
Comp #: 2357 Stone Veneer - Maintain/Repair

Evaluation: Some stone veneer was used for cladding on small portions of the buildings. No cracked grout or broken stone were observed during our limited visual review. Stone veneer is a relatively low maintenance item. Inspect periodically and repair as needed using operation and maintenance funds. No Reserve funding suggested at this time.

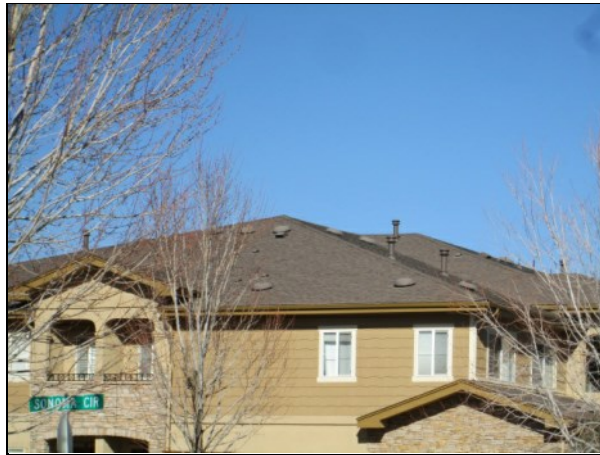
Comp #: 2377 Comp Shingle Roof - Replace (Ph 1)

Evaluation: Generally good condition of roofing system observed during our limited visual review. Closed valleys were observed. Ventilation (the lack of which can greatly reduce the roof's useful life) was observed at the ridge. Ridge venting appeared to be provided by roof jacks. Visible portions of roof flashing were observed at the rake, headwall, and sidewall. Debris was not observed on the roof surface. A reserve study conducts only a limited visual review, and many of the critical waterproofing and ventilation items of the roof are not readily viewable. For a full evaluation have a professional roof consultant/contractor perform a thorough up-close survey of your entire roof system, including attic inspection (if any).

Useful Life:
25 years

Remaining Life:
11 years

Costs below factors replacement with an architectural grade laminated shingle.

As routine maintenance, many manufacturers recommend inspections at least twice annually (once in the fall before the snow season and again in the spring) and after large storm events. Promptly replace any damaged/missing sections or any other repair needed to ensure waterproof integrity of roof. Keep roof surface, gutters, and downspouts clear and free of debris.

At the time of re-roofing, we recommend that you hire a professional consultant to evaluate the existing roof and specify the new roof materials/design, provide installation oversight. We recommend that all Associations hire qualified consultants whenever they are considering having work performed on any building envelope (waterproofing) components including; roof, walls, windows, decks, exterior painting, and caulking/sealant.

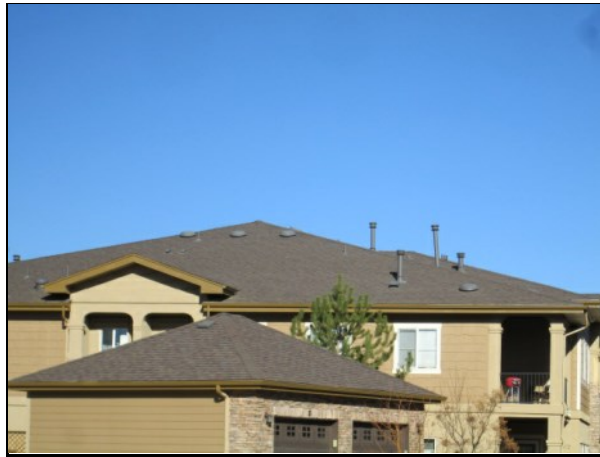
Comp #: 2377 Comp Shingle Roof - Replace (Ph 2)

Evaluation: Generally good condition of roofing system observed during our limited visual review. Closed valleys were observed. Ventilation (the lack of which can greatly reduce the roof's useful life) was observed at the ridge. Ridge venting appeared to be provided by roof jacks. Visible portions of roof flashing were observed at the rake, headwall, and sidewall. Debris was not observed on the roof surface. A reserve study conducts only a limited visual review, and many of the critical waterproofing and ventilation items of the roof are not readily viewable. For a full evaluation have a professional roof consultant/contractor perform a thorough up-close survey of your entire roof system, including attic inspection (if any).

Useful Life:
25 years

Remaining Life:
13 years

Costs below factors replacement with an architectural grade laminated shingle.

As routine maintenance, many manufacturers recommend inspections at least twice annually (once in the fall before the snow season and again in the spring) and after large storm events. Promptly replace any damaged/missing sections or any other repair needed to ensure waterproof integrity of roof. Keep roof surface, gutters, and downspouts clear and free of debris.

At the time of re-roofing, we recommend that you hire a professional consultant to evaluate the existing roof and specify the new roof materials/design, provide installation oversight. We recommend that all Associations hire qualified consultants whenever they are considering having work performed on any building envelope (waterproofing) components including; roof, walls, windows, decks, exterior painting, and caulking/sealant.

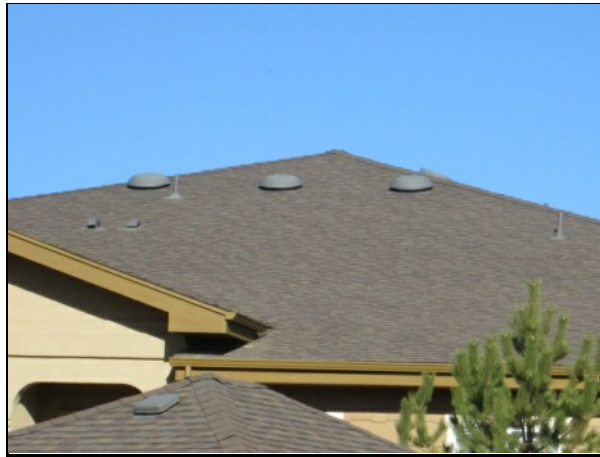
Comp #: 2377 Comp Shingle Roof - Replace (Ph 3)

Useful Life:
25 years

Remaining Life:
18 years

Costs below factors replacement with an architectural grade laminated shingle.

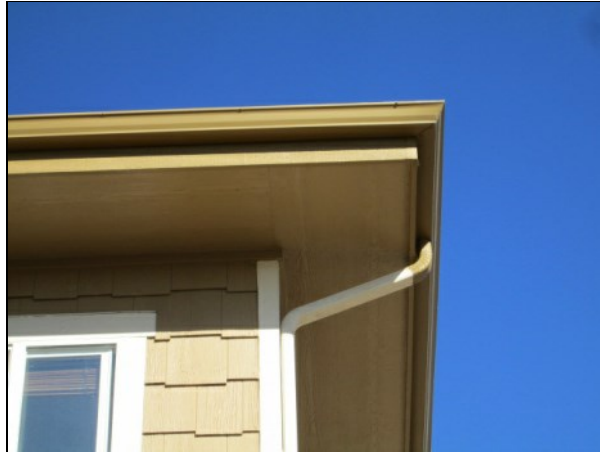
Comp #: 2385 Gutters/Downspouts - Replace (Ph 1)

Useful Life:
25 years

Remaining Life:
11 years

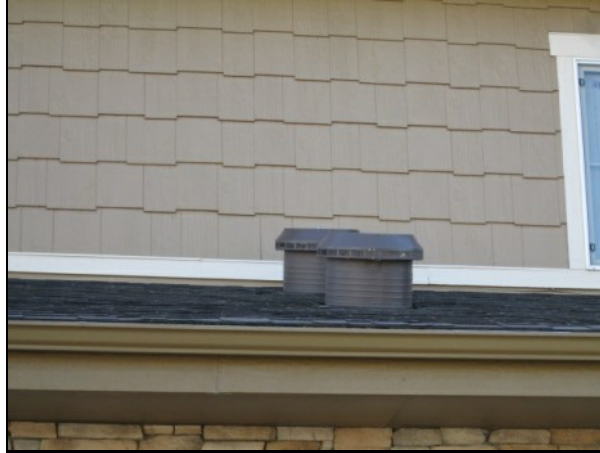
Comp #: 2385 Gutters/Downspouts - Replace (Ph 2)

Useful Life:
25 years

Remaining Life:
13 years

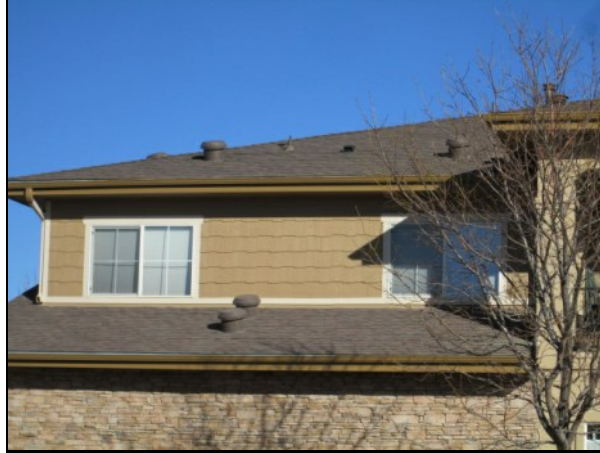
Comp #: 2385 Gutters/Downspouts - Replace (Ph 3)

Useful Life:
25 years

Remaining Life:
18 years
